# SEISMIC REHABILITATION OF TYPICAL SCHOOLS IN PUERTO RICO

MASTER OF ENGINEERING  
IN  
CIVIL ENGINEERING

UNIVERSITY OF PUERTO RICO  
MAYAGÜEZ CAMPUS

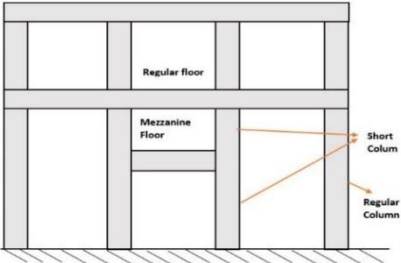
Figure 3. Building with a mezzanine floor.

The short column effect is one of the structural defects most frequently noticed after a destructive earthquake. It is commonly noticed in buildings with a mezzanine floor (Figure 3) , buildings on a sloped ground where the columns have different heights within the same story (Figure 4), or due to the presence of partial masonry walls between the columns that vertically cover the space from the floor to the threshold of a window (Figure 5). The third scenario is typically noticed in school buildings for the needs of lighting and ventilation.

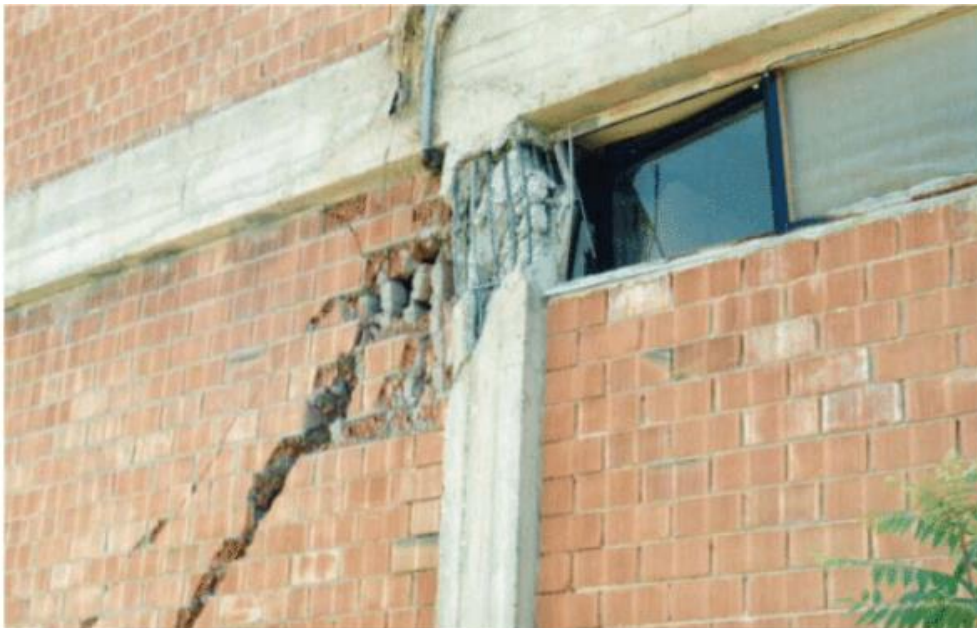
Figure 9. Short Column failure in the Adana Ceyhan earthquake, Turkey, 1998.

An earthquake with a 6.2 moment magnitude and an IX maximum intensity occurred on June 27, 1998, at 4h56, local time, in southern Turkey [8], historically known as Cilicia near the city of Ceyhan (population 100,000). The European macro seismic scale classifies an earthquake with such intensity as destructive. Reports revealed the coordinates of the epicenter at 36.95°N and 35.31°E and the focal depth at 23 km. Followed by numerous aftershocks, the event caused severe damages as a consequence of a strong motion with a PGA of 0.28 g. According to the reports, 12 buildings collapsed, 120 others were classified as moderately damaged in Ceyhan. Also, in the nearest provincial capital, Adana (population 1.2 million) there were at least 145 deaths, 1,500-1,600 people injured, and 8,800 people displaced. The losses were estimated at US\$1 billion. Inadequate structural building designs were mostly the cause of the damages that left many thousands homeless in Adana, and Ceyhan, where the presence of short column effect was noticeable. This effect is caused by masonry walls that reduced the effective height of the columns.

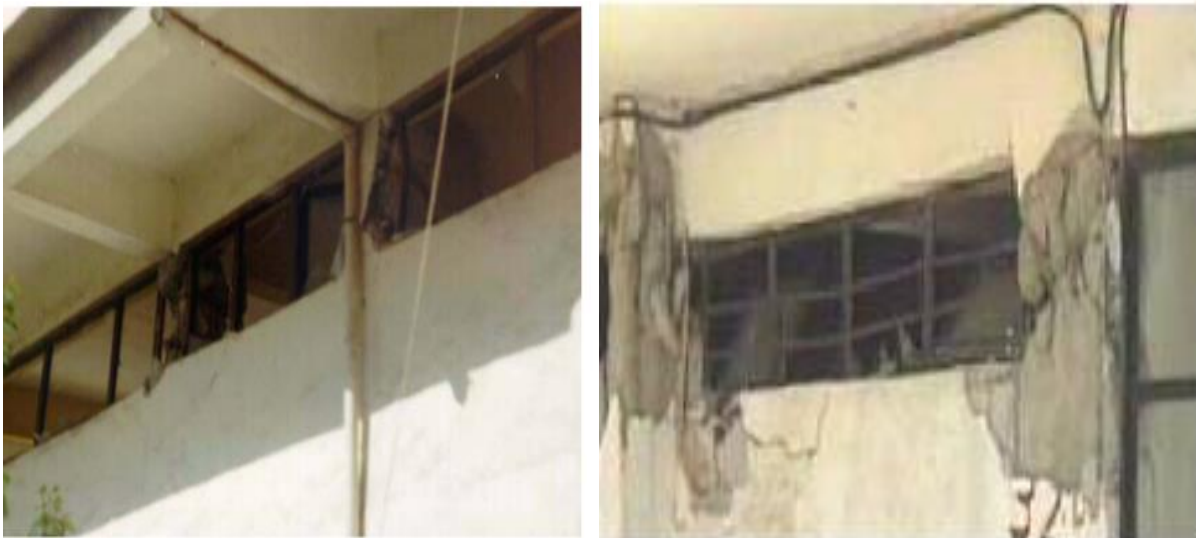
Figure 10. Damages due to the short column effect in the Izmit Earthquake, Turkey 1999.

The 1999 Kocaeli earthquake struck the Kocaeli province of northwestern Turkey on Tuesday, August 17, 1999, at 3:02 A.M., local time with a moment magnitude of 7.4 [9]. The PGA was 0.4g. Records displayed a fault rupture of 110 km, approximately. The Kocaeli province is considered as the area with the densest population of Turkey and most important area of the Turkish industry. As it is presumed to drift slowly, the Earth's crust unexpectedly ruptures along a western branch of the 1,500-km-long North Anatolian fault system, causing the 1999 Kocaeli earthquake. The Turkish government estimated 17,127 deaths, 43,953 injuries, and the displacement of more than 250,000 people because of this event. Approximately 121 tent cities were required for emergency housing, and 214,000 residential units and 30,500 business units were damaged. The affected buildings were mostly built using reinforced concrete. Poor construction practices were performed; thus, those buildings were not compliant to the local building code in vigor. The strong velocity and long duration of the pulse of the ground motion were important factors that caused damages and collapses of the buildings, but not the peak ground acceleration (PGA) registered near the fault, which were below average for an earthquake of such magnitude.

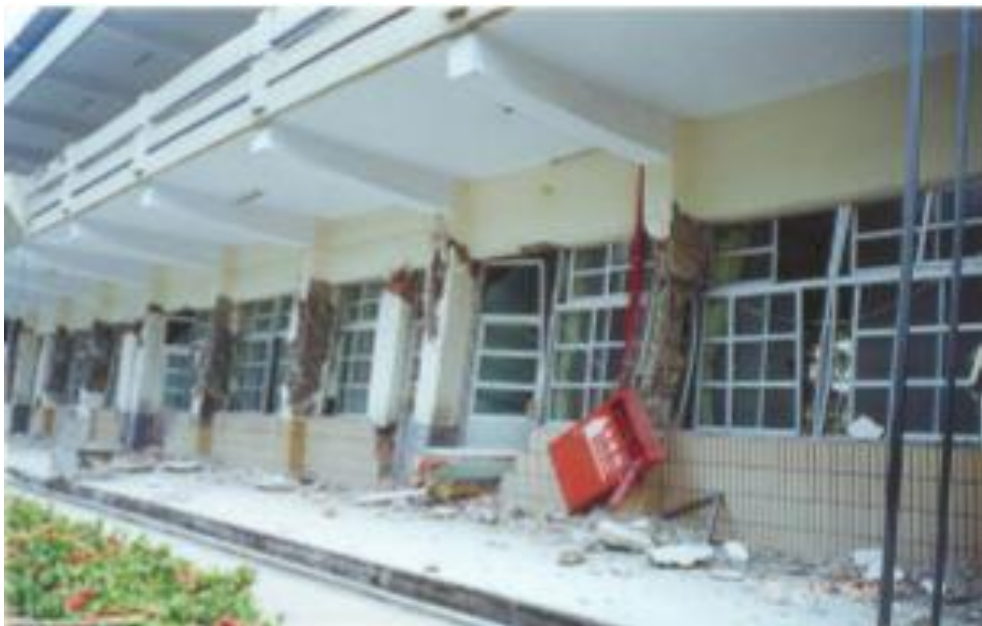
Figure 11. School damaged due to the short column effect.

On September 21, 1999, a disastrous earthquake of  $M_w = 7.6$  followed by large aftershocks that occurred in the city of Chi-Chi, the center of Taiwan. More than 2,400 people died, some 10,700 were injured, over 8,500 buildings were destroyed and another 6,200 were seriously damaged. The duration of the strong motion was about 30 seconds. Records at the north end of the strong ground motion rupture zone related PGAs of 0.4 g, and from 1.0 g to 2.0 g at the south end of the earthquake rupture zone. Compared to the 1999 Kocaeli earthquake in Turkey, the energy released by the Chi-Chi earthquake was 50% greater. This earthquake caused damages in economic terms and human lives in structures as schools, bridges, dams, embankments, and residences. Heavy losses to schools and public facilities were disclosed, where 43 schools in Nantou and Taichung were destroyed and 700 schools were damaged [10]. The shear column effect was one of the main anomalies noticed in schools, in the direction parallel to the exterior corridor outside the classrooms where windows above half-height infill shortened the effective length of almost all the columns [11].

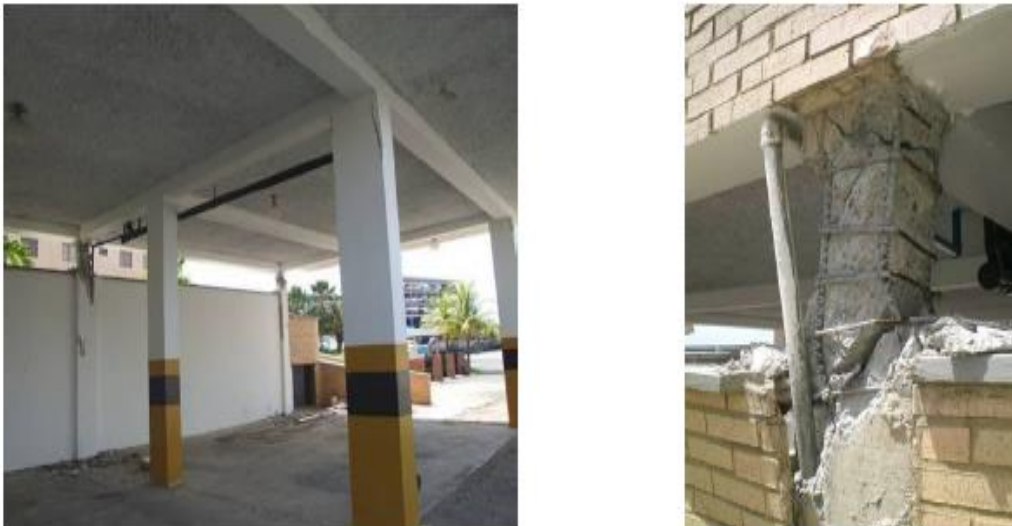
Figure 12. Short Column effect generated by reinforced concrete walls in a building in Tucacas, Venezuela during the September 2009 earthquake.

On September 12, 2009, an earthquake of magnitude 6.2 Mw occurred in Tucacas, Venezuela, located about 50 km from the epicenter [12]. It severely damaged several buildings. Short column effect was the protagonist and was generated by the presence of a reinforced concrete wall in one of the structural axes, which caused the failure of all the columns of that axis. On the upper floors, the columns of that same axis showed cracks of horizontal orientation, leaving in evidence the total degradation of the ability to support the "short columns" of the lower level and that portion of the structure "hung" from the upper columns generating traction. Fortunately, the structural redundancy and the low intensity of the earthquake in the locality, allowed tensions to be redistributed towards the columns of the neighboring axes, avoiding the collapse of the structure. This building was disabled immediately after the earthquake occurred due to its precarious condition.

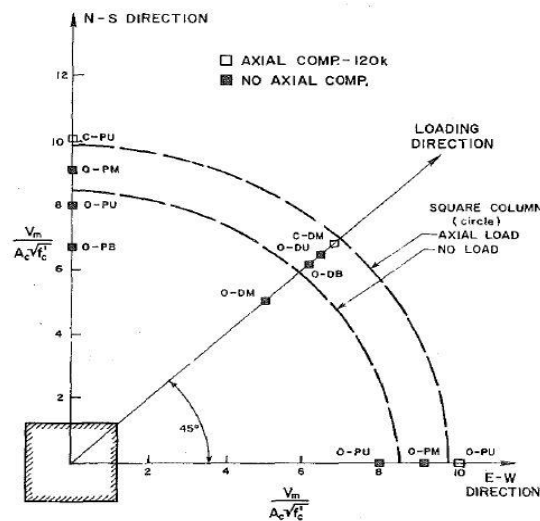
Figure 13. Shear Strength vs direction of loading - Square column.

In 1984, Umehara and Jirsa [13] conducted research on short columns in reinforced concrete buildings and observed their performance under seismic events. They ran 20 experimental tests to define the shear strength of the short columns under loadings using interaction curves. They concluded that when short columns are submitted to loads in both directions, failure occurs when the maximum capacity in a specified direction reaches the deflection at the maximum shear capacity of columns under loadings in one direction. They also evaluated shear strength using elliptical or circular interaction diagrams.

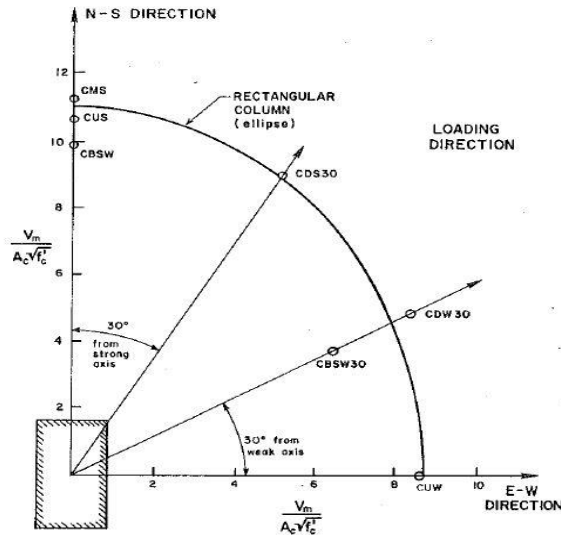
Figure 14. Shear Strength vs direction of loading - Rectangular column.

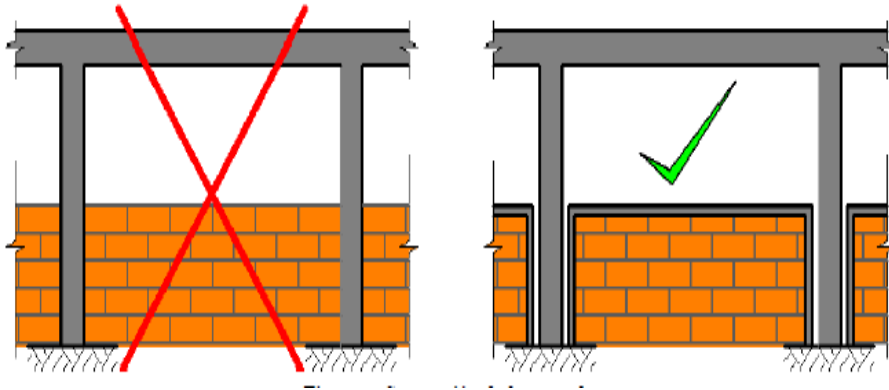
Figure 15. Separation of the columns from the masonry walls.

In 2018, Beauperthuy and Urich [16] also studied the behavior of short columns, one of the most common causes of catastrophic damage in seismic events. According to the authors, the best and the most economical solution is to avoid the short column effect by conveniently separating the columns from other components (Figure 15), which limits the free deformation of the columns. The other solution is to incorporate the non-structural components in the analysis and design since the real problem is not that the columns are "short", but that the influence of non-structural components has not been considered in the project. When realistic conditions are considered in the models, non-structural and structural components can be properly designed. Hence, deformation compatibility can be verified for the overall performance of the structural system and the rest of the building components. They proposed to incorporate infill wall segments on both sides of the short columns for the rehabilitation and reinforcement of the structure (Figure 16).

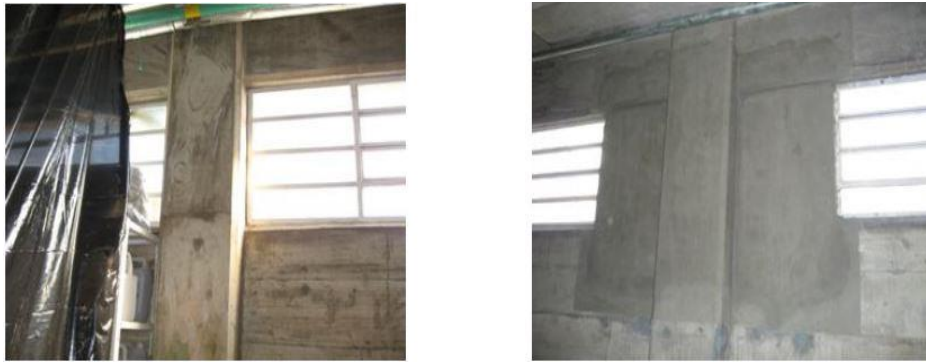
Figure 16. Incorporation of infill wall segments on both side of the short columns.

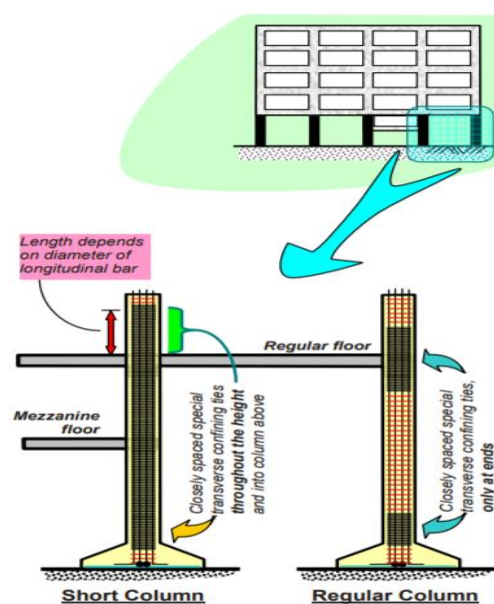
Figure 17. Details of reinforcement of a short column versus a regular column.

Nowadays, many building codes have considered the formation of the short column effect and have provided specified design requirements so that the short columns, if present, are properly designed to be compliant to the building codes in vigor. Special requirements within those codes are established to address the issue. For instance, the building code of India (India IS: 13920-1993) belongs to that list. Instead of the usual stirrups at the level of the confinement zone for regular columns, the Indian Building Code establishes special confining reinforcement requirements for short columns. This special reinforcement must be applied throughout the entire height of the column, and must be extended into the column vertically above, as it is shown in Figure 17 [17].

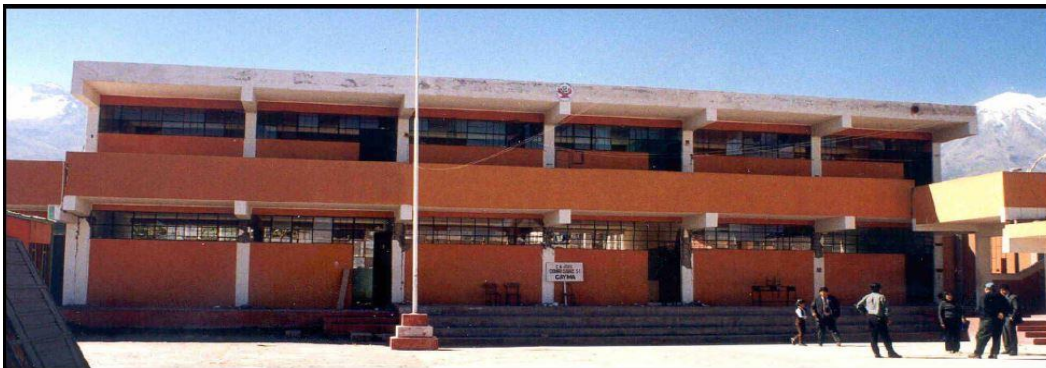
Figure 18. School building before 1997 damaged in the Atico earthquake, Peru, 2001.

Besides the Indian Code, a study conducted by Muñoz, et al. [18] on Peruvian school buildings, in 2004, states that the educational infrastructure built before 1997 has suffered considerable damages during recent earthquakes, while those designed and built under the 1997 Peruvian Seismic Code have not suffered any sort of structural damages in the 8.4 Mw 2001 earthquake. One of the important reforms established in the 1997 Peruvian Seismic Code is the increment in stiffness in the longitudinal direction. In fact, the short column effect in school buildings arises from a lack of stiffness in the longitudinal direction, and Peruvian school buildings were, traditionally, flexible in the longitudinal direction. Hence, the 1997 Peruvian Seismic Code takes into consideration the formation of the short column effect in school buildings by increasing the demand in stiffness in the longitudinal direction while the transverse direction remains the same since the structural arrangement is compliant to the seismic requirements of the new code. The June 2001 earthquake has extensively damaged traditional school buildings in Peru while the modern school buildings performance has been excellent.

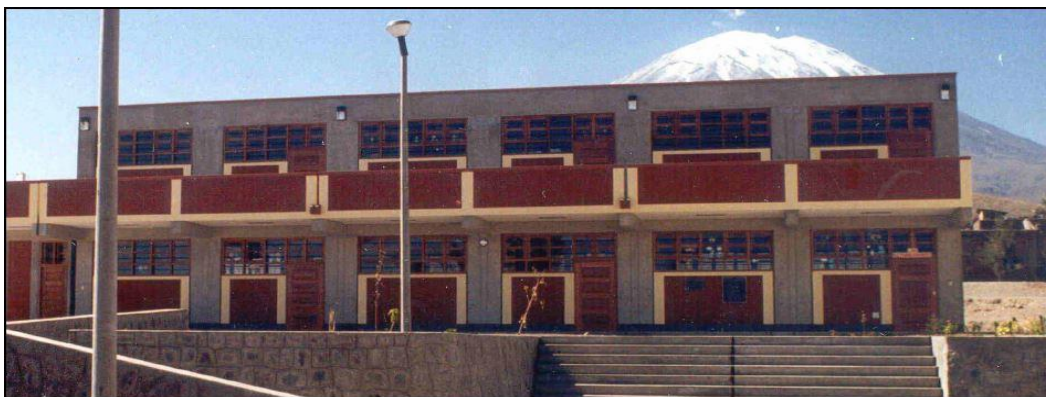
Figure 19. Modern school building, after 1997, undamaged in the Atico earthquake, Peru, 2001.

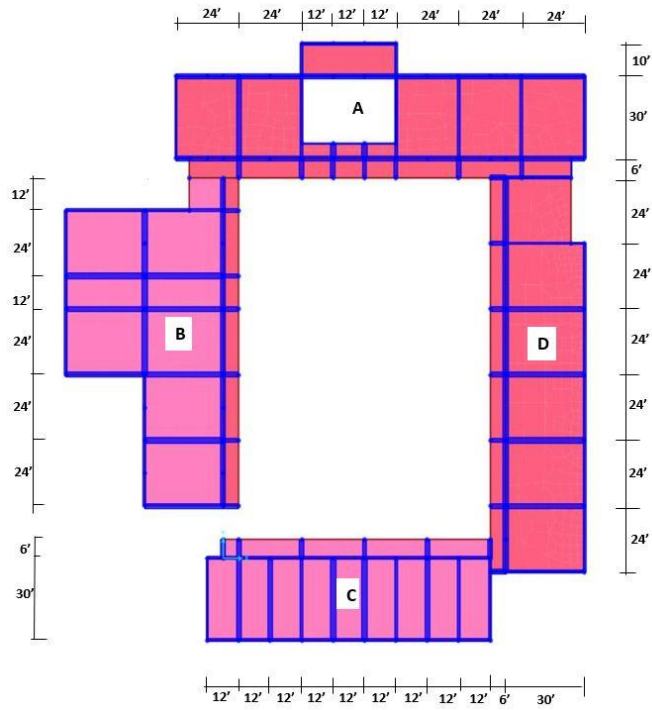
Figure 20. First floor top view on SAP2000.

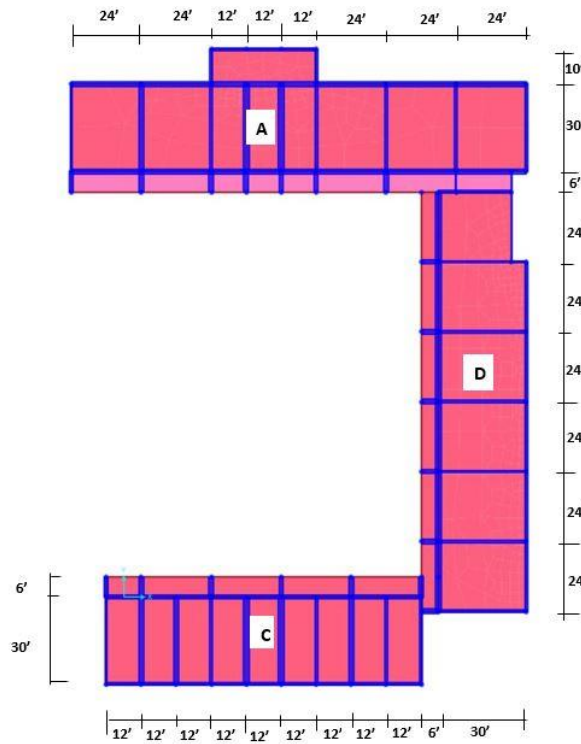
Figure 21. Second floor top view on SAP2000.

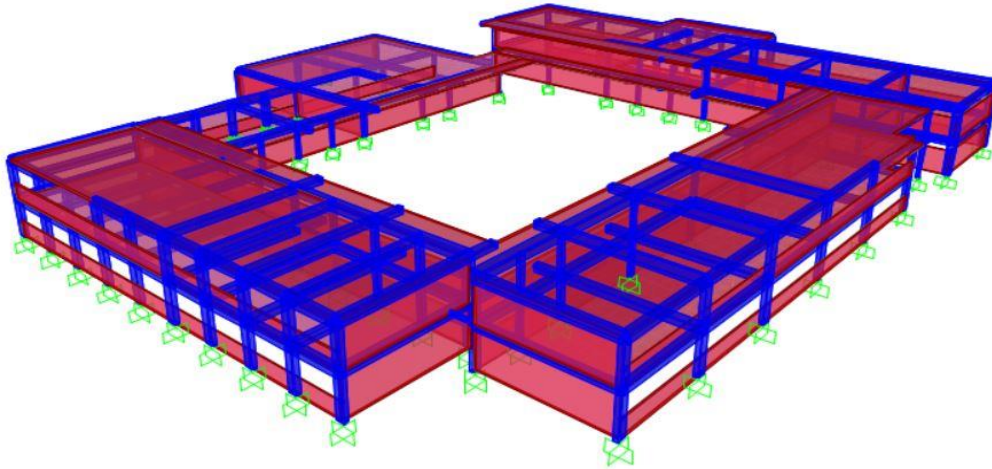
Figure 22. 3D model on SAP2000.

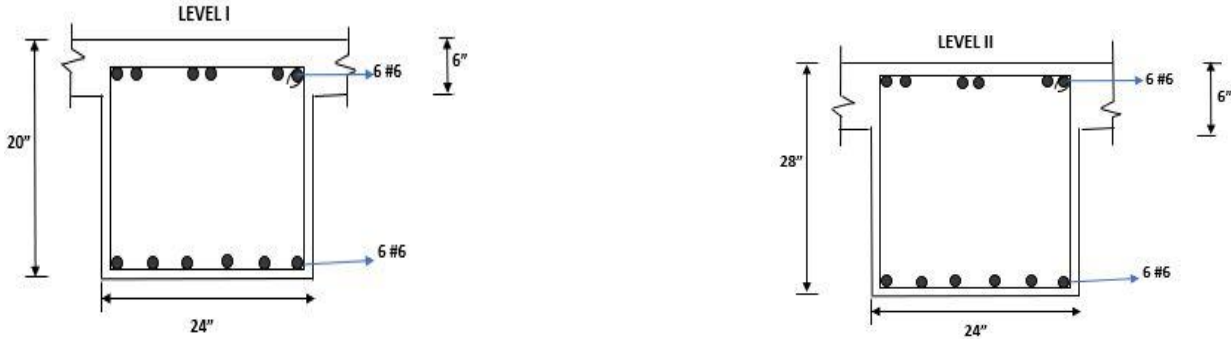
Figure 25. Longitudinal beam section and reinforcement of the Frame I.

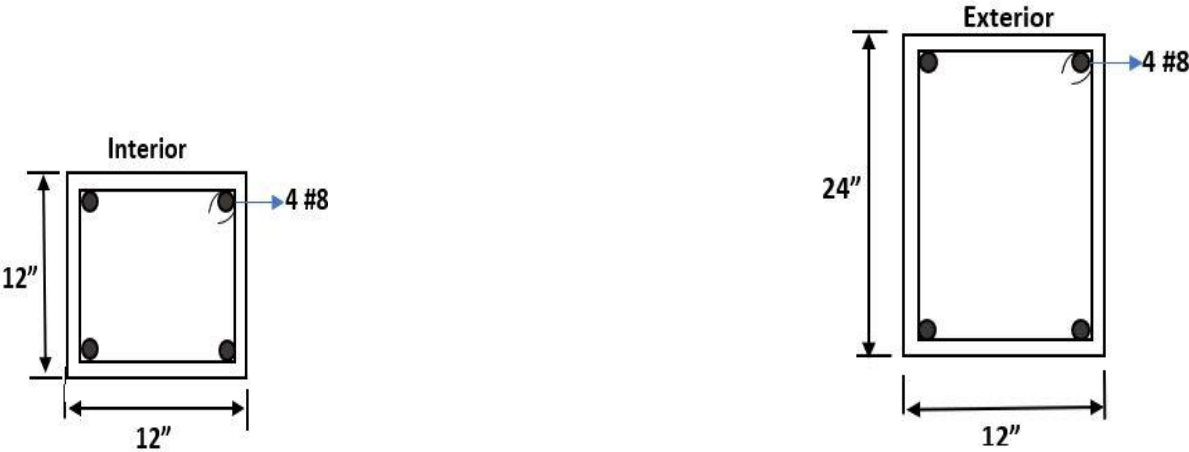
Figure 26. Interior and exterior columns section and reinforcement.

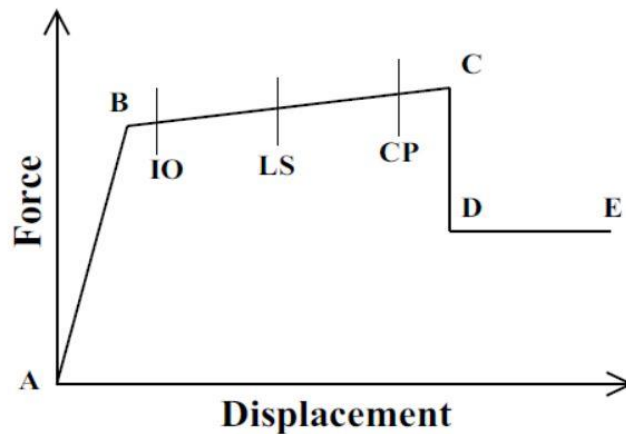
Figure 30. Idealized Pushover curves.

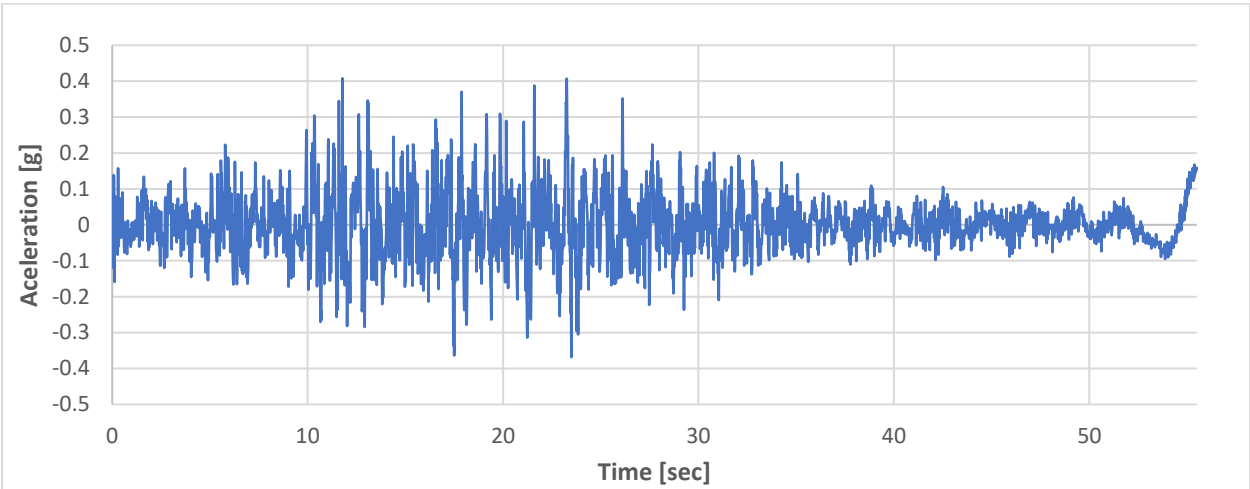
**Probable earthquake for San Juan, PR in soil Type D: JAP03.104**

Figure 31. Probable earthquake JAP03.104 for San Juan PR for soil type D.

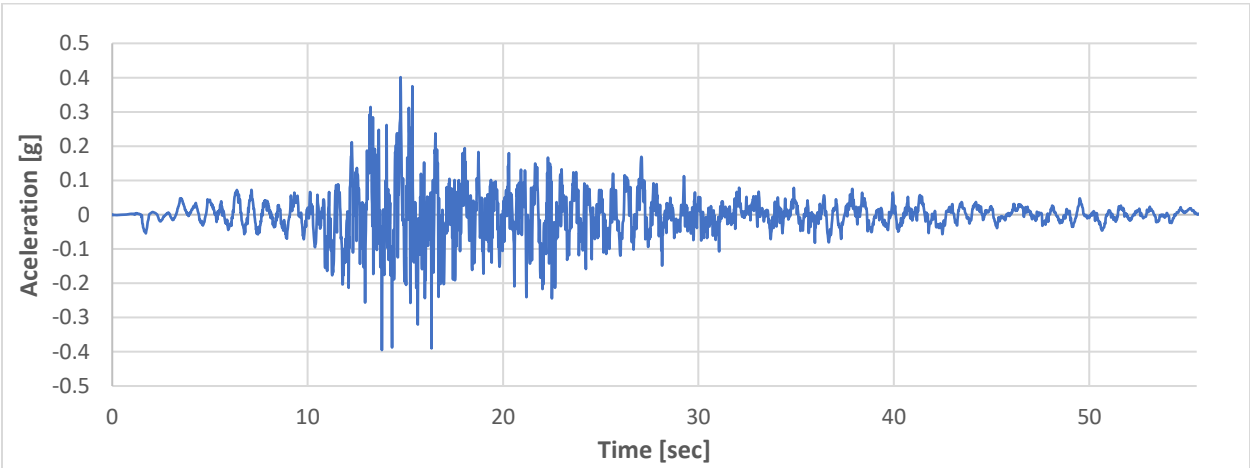
**Probable earthquake for San Juan, PR in soil Type D: JAP03.173**

Figure 32. Probable earthquake JAP03.173 for San Juan PR for soil type D.

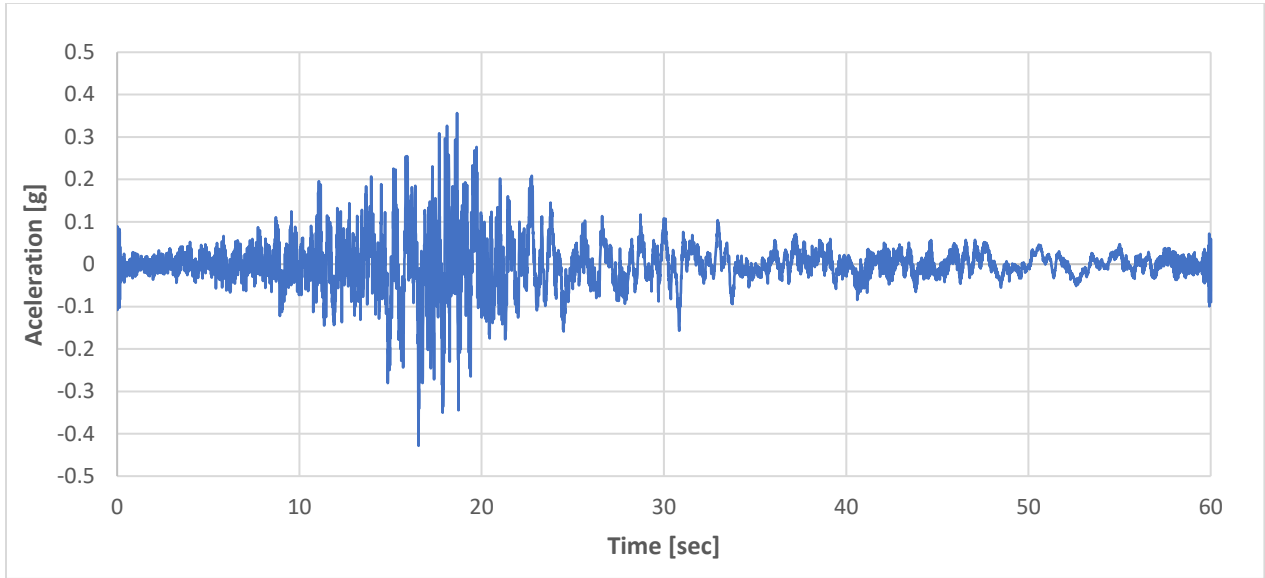
**Probable earthquake for San Juan, PR in soil Type D: MEX03.112**

Figure 33. Probable earthquake MEX03 for San Juan PR for soil type D.

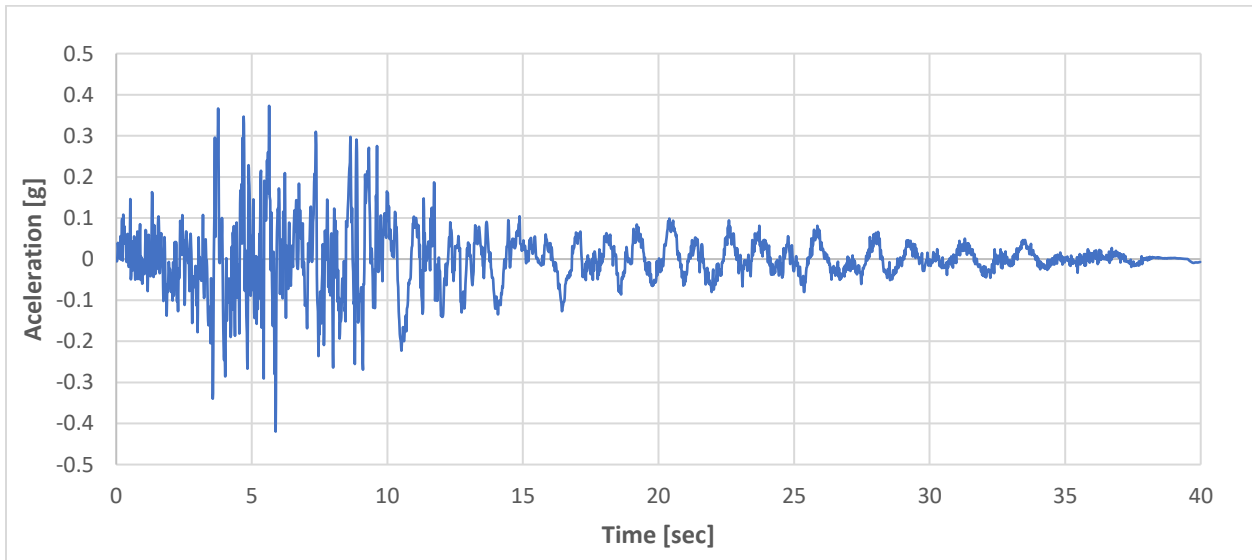
**Probable earthquake for San Juan, PR in soil Type D: PACOIMAW.V2**

Figure 34. Probable earthquake PACOIMAW for San Juan PR for soil type D.

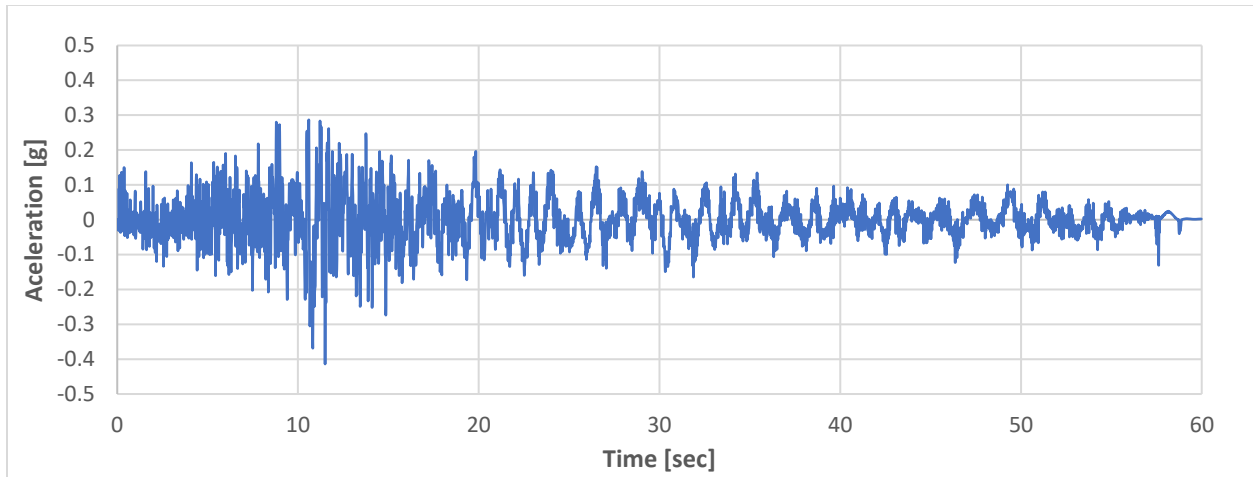
**Probable earthquake for San Juan, PR in soil Type D: ROLLHILL.V2**

Figure 35. Probable earthquake Rollhill for San Juan PR for soil type D.

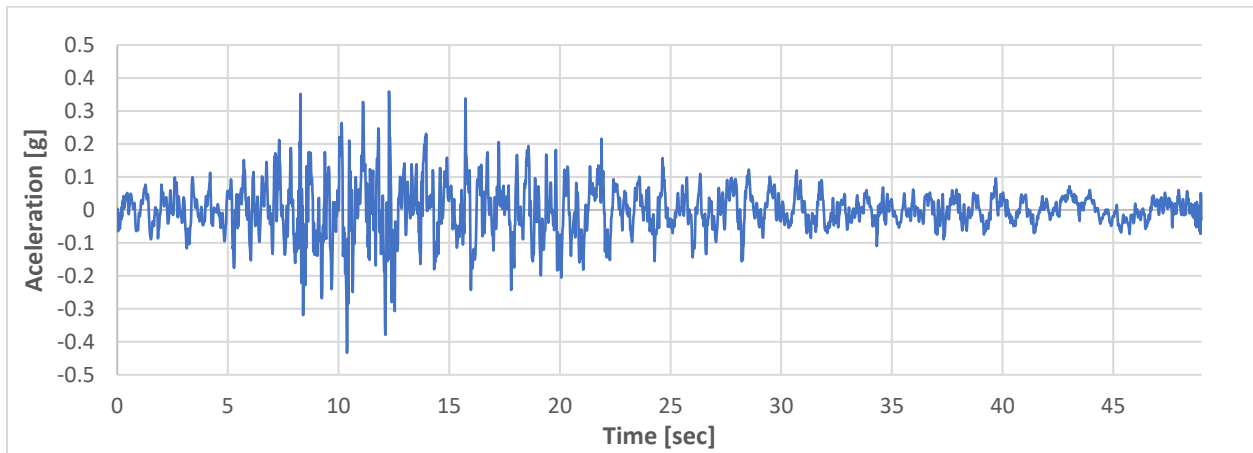
**Probable earthquake for San Juan, PR in soil Type D: USAKA02.067**

Figure 36. Probable earthquake USAKA02 for San Juan PR for soil type D.

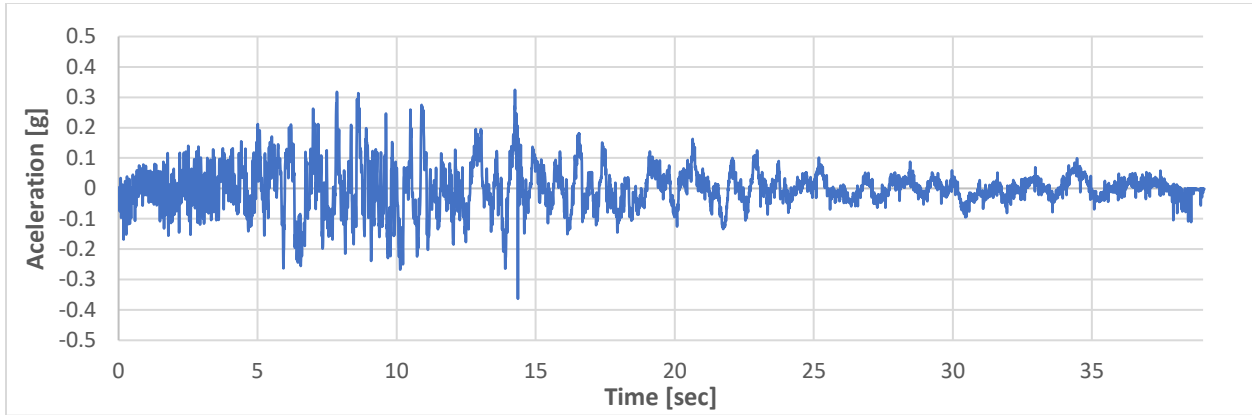
**Probable earthquake for San Juan, PR in soil Type D: USAKA66.001**

Figure 37. Probable earthquake USAKA66 for San Juan PR for soil type D.

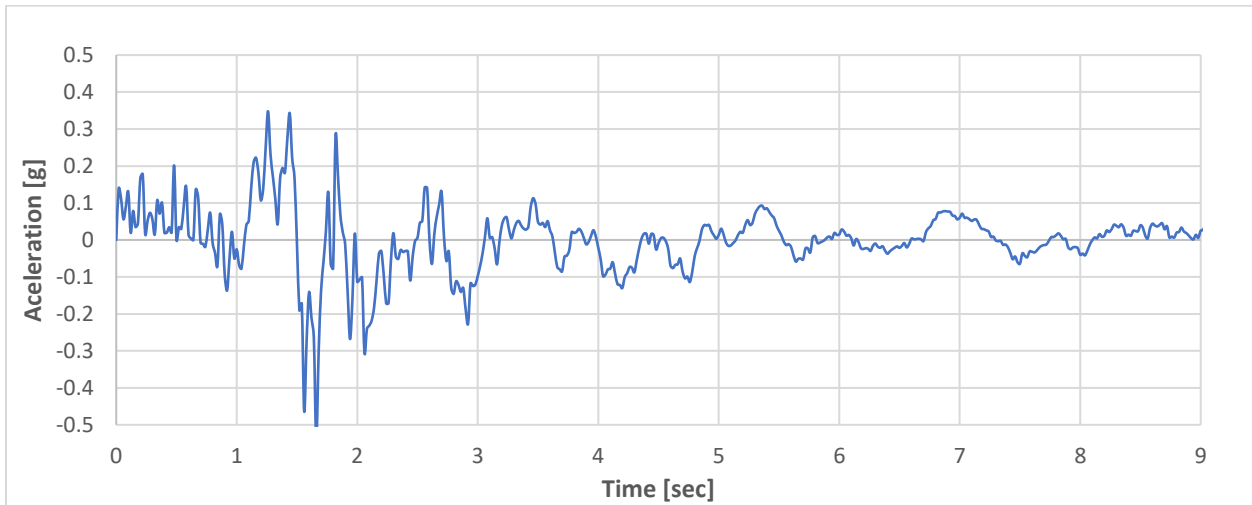
**Probable earthquake for Ponce, PR in soil Type D: CIG.EW**

Figure 38. Probable earthquake CIG for Ponce, PR for soil type D.

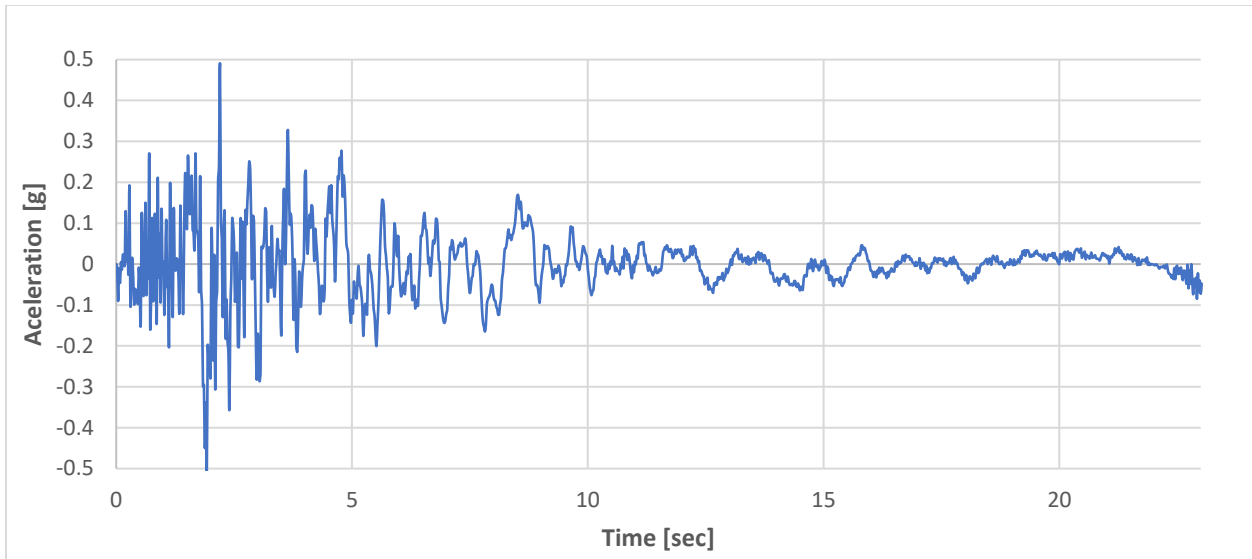
**Probable earthquake for Ponce, PR in soil Type D: HSH.EW**

Figure 39. Probable earthquake HSH for Ponce, PR for soil type D.

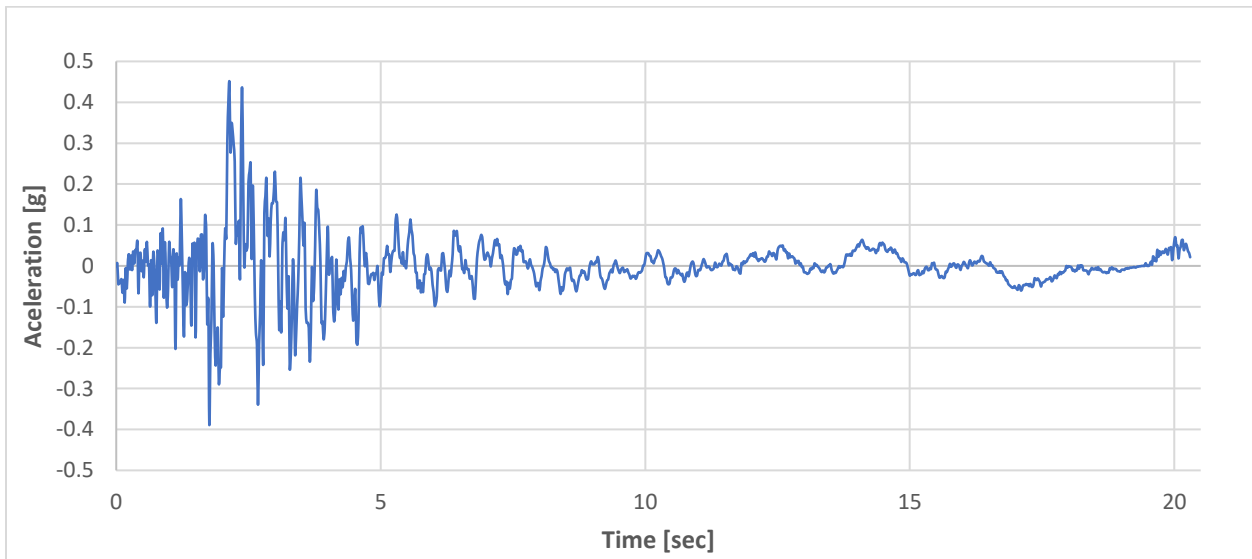
**Probable earthquake for Ponce, PR in soil Type D: IGN.EW**

Figure 40. Probable earthquake IGN for Ponce, PR for soil type D.

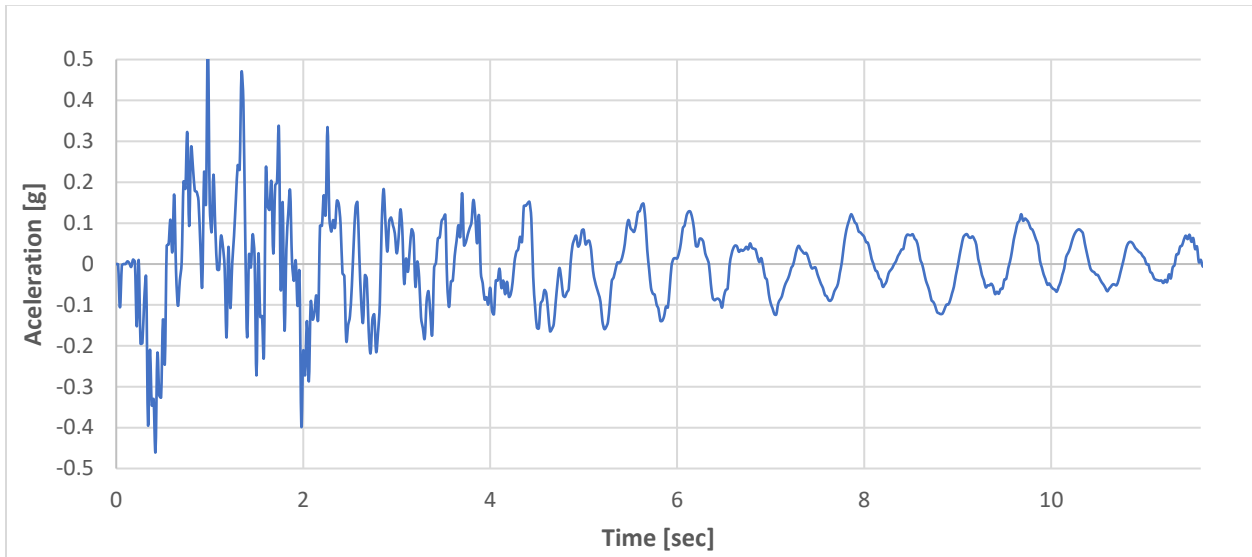
**Probable earthquake for Ponce PR in soil Type D: IVU.EW**

Figure 41. Probable earthquake IVU for Ponce, PR for soil type D.

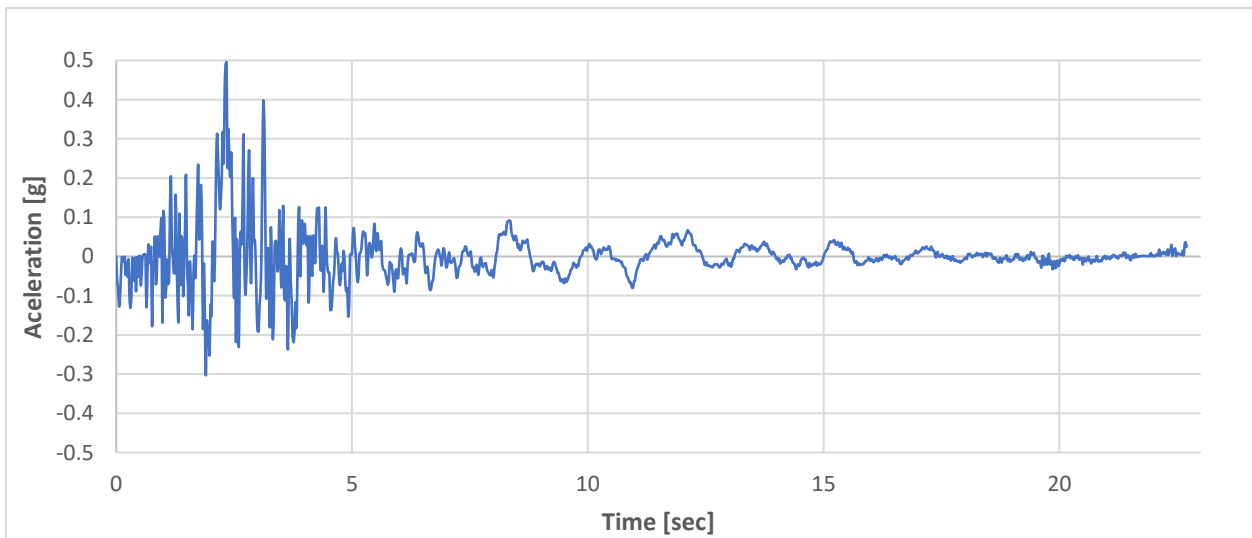
**Probable earthquake for Ponce, PR in soil Type D: UCA.EW**

Figure 42. Probable earthquake UCA for Ponce, PR for soil type D.

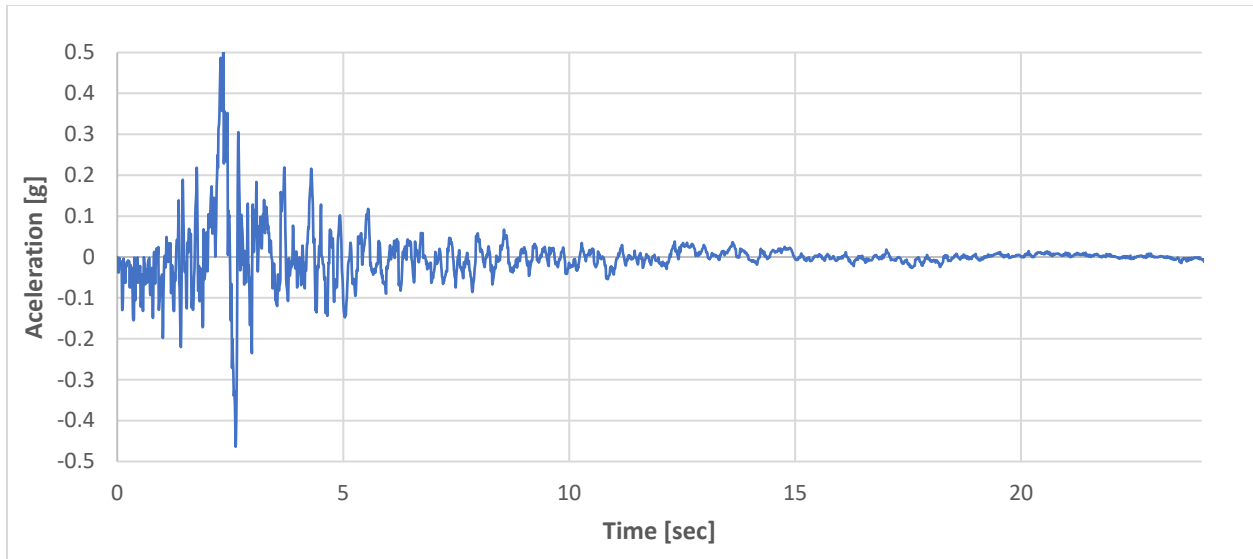
**Probable earthquake for Ponce, PR in soil Type D: USACA18.033**

Figure 43. Probable earthquake USACA18 for Ponce, PR for soil type D.

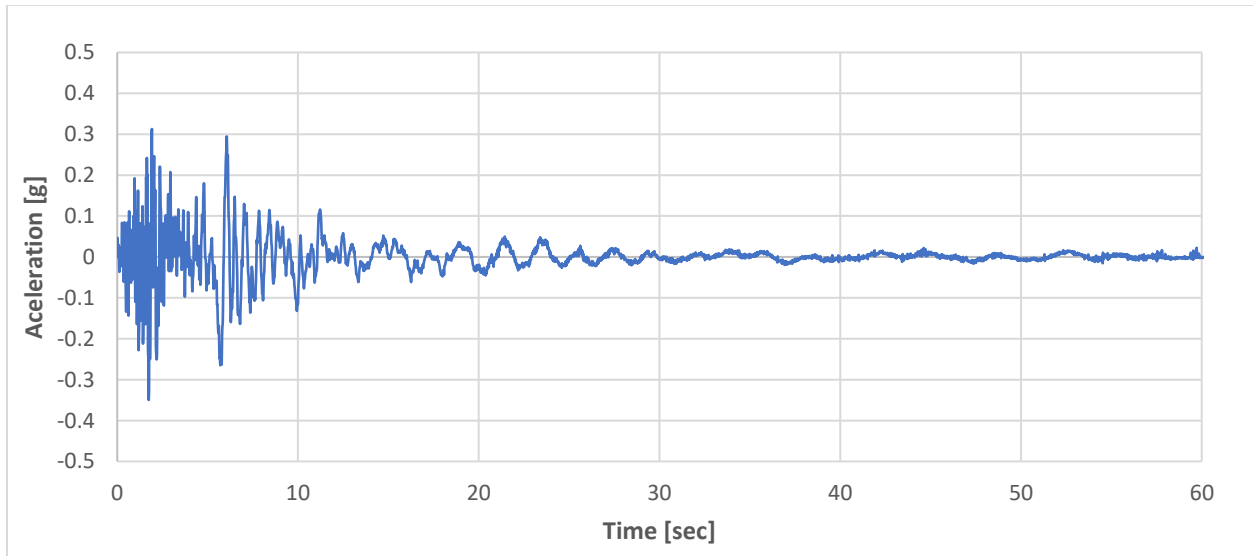
**Probable earthquake for Ponce, PR in soil Type D: USACA36.011**

Figure 44. Probable earthquake USACA36 for Ponce, PR for soil type D.

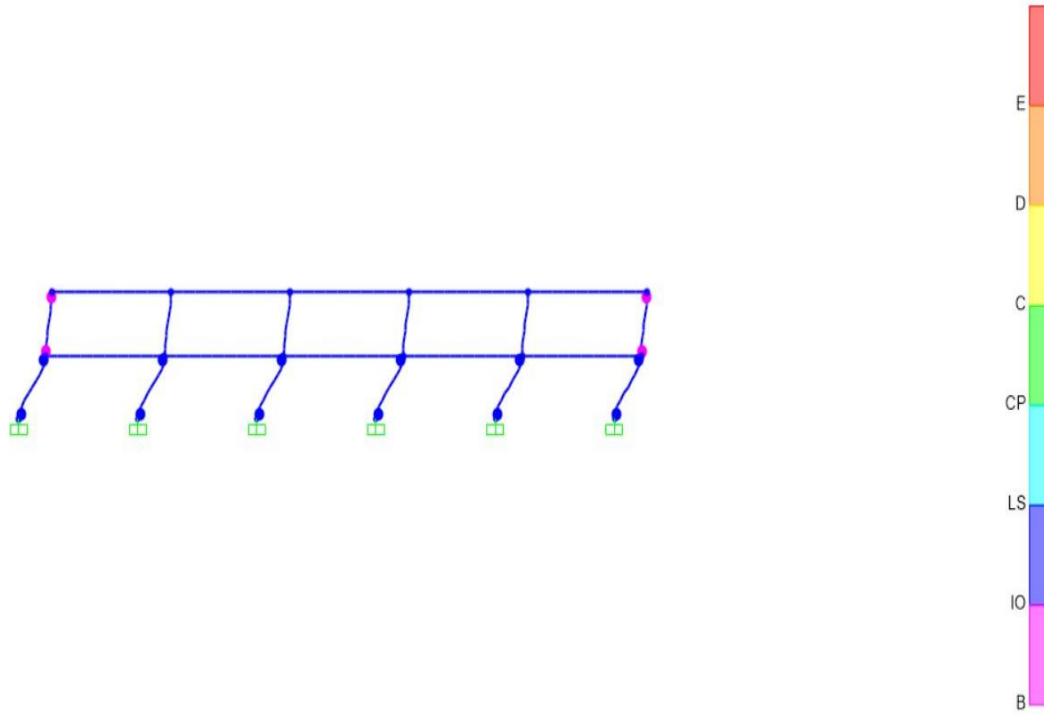
Figure 46. Sequence of plastic hinge formation – Case I.

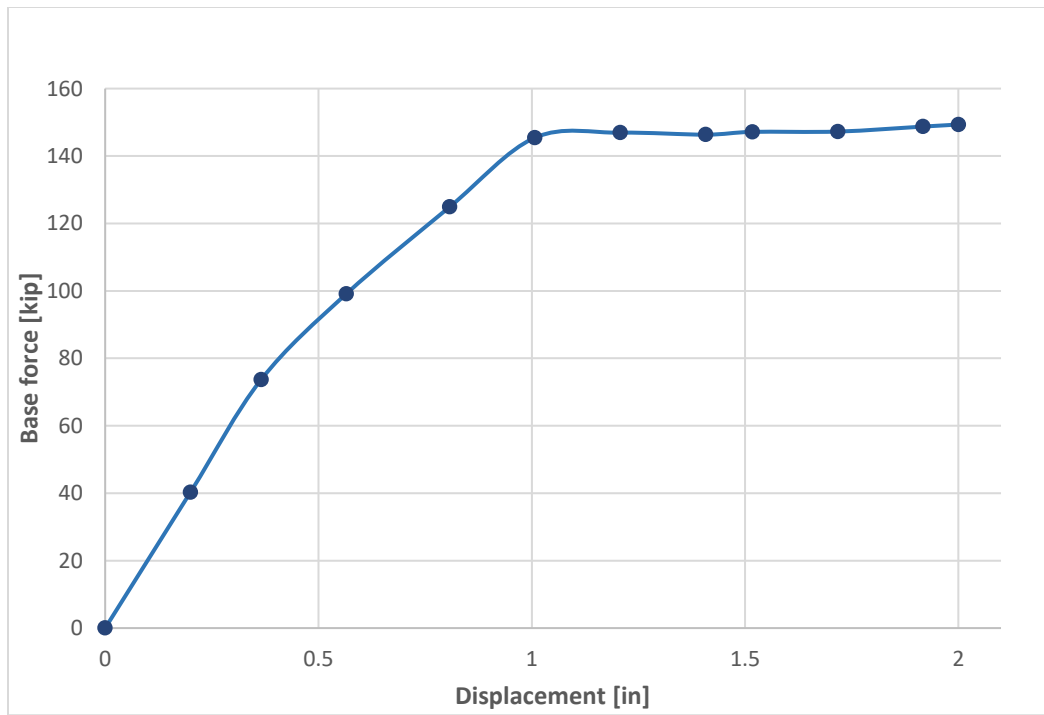
Figure 47. Pushover capacity curve of Frame I – Case I.

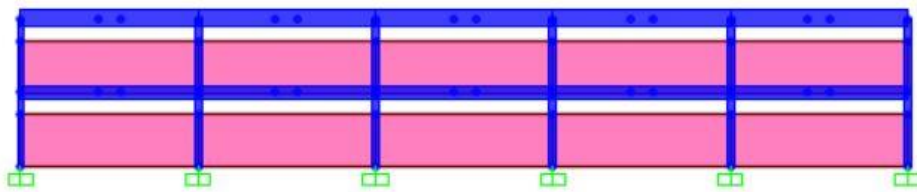
**Case II: Frame I with masonry walls in the longitudinal direction when shear failures were not considered by SAP2000.**

Figure 48. Frame I 2D model with masonry walls in the longitudinal direction in SAP2000.

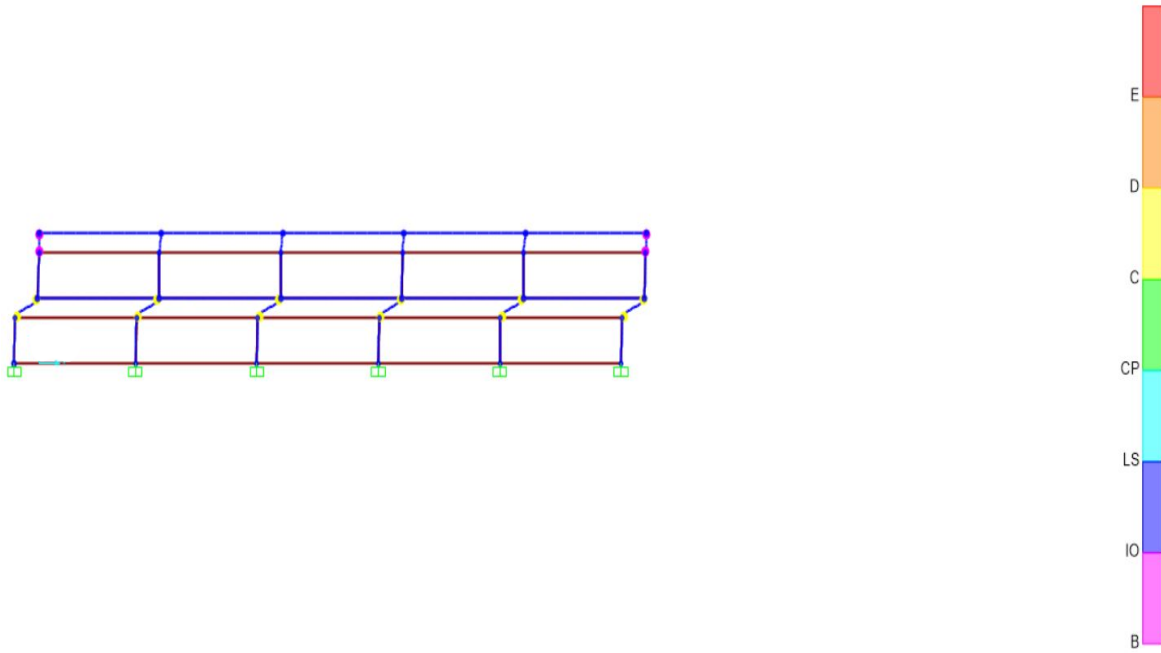
Figure 49. Sequence of plastic hinge formation – Case II.
