# SEISMIC REHABILITATION OF TYPICAL SCHOOLS IN PUERTO RICO

MASTER OF ENGINEERING  
IN  
CIVIL ENGINEERING

UNIVERSITY OF PUERTO RICO  
MAYAGÜEZ CAMPUS

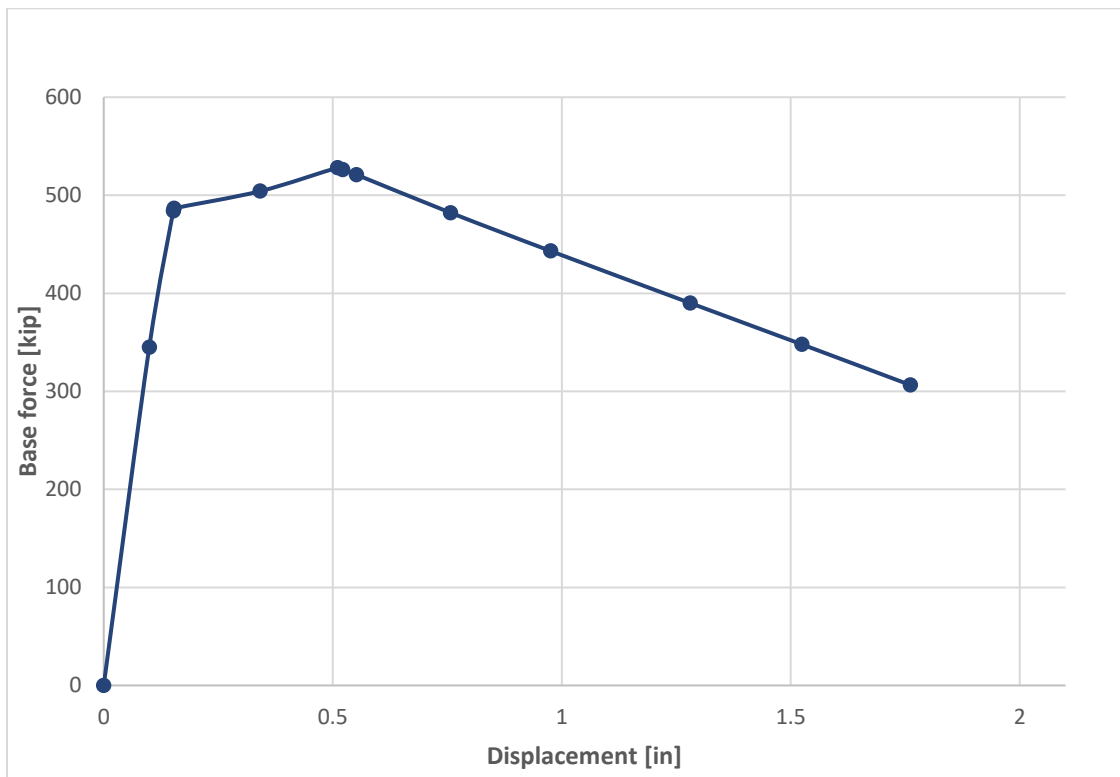
Figure 50. Pushover capacity curve of Frame I – Case II.

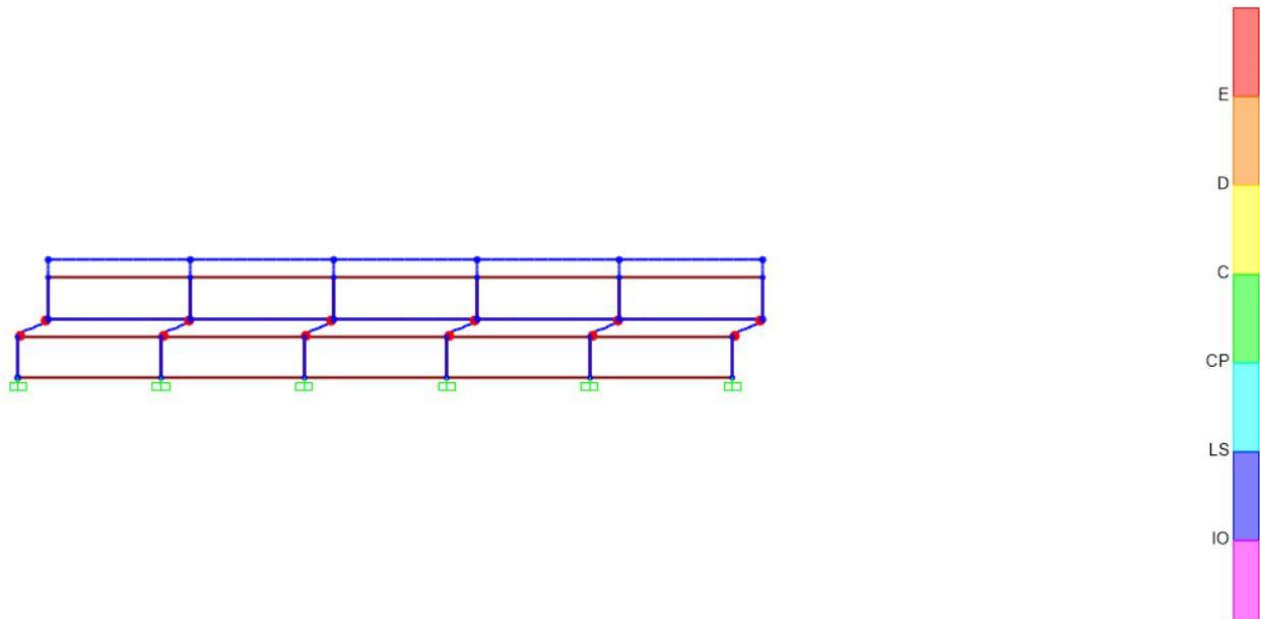
**Case III: Frame I with masonry walls in the longitudinal direction with shear failures considered in SAP2000.**

Figure 51. Sequence of plastic hinge formation – Case III.

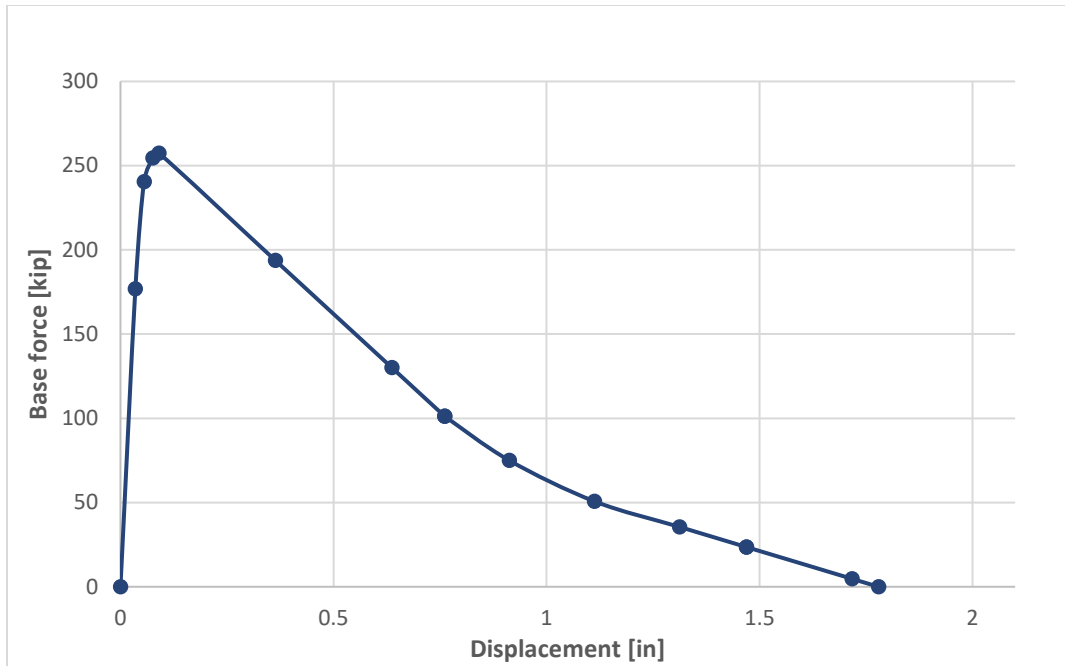
Figure 52. Pushover capacity curve of Frame I – Case III.

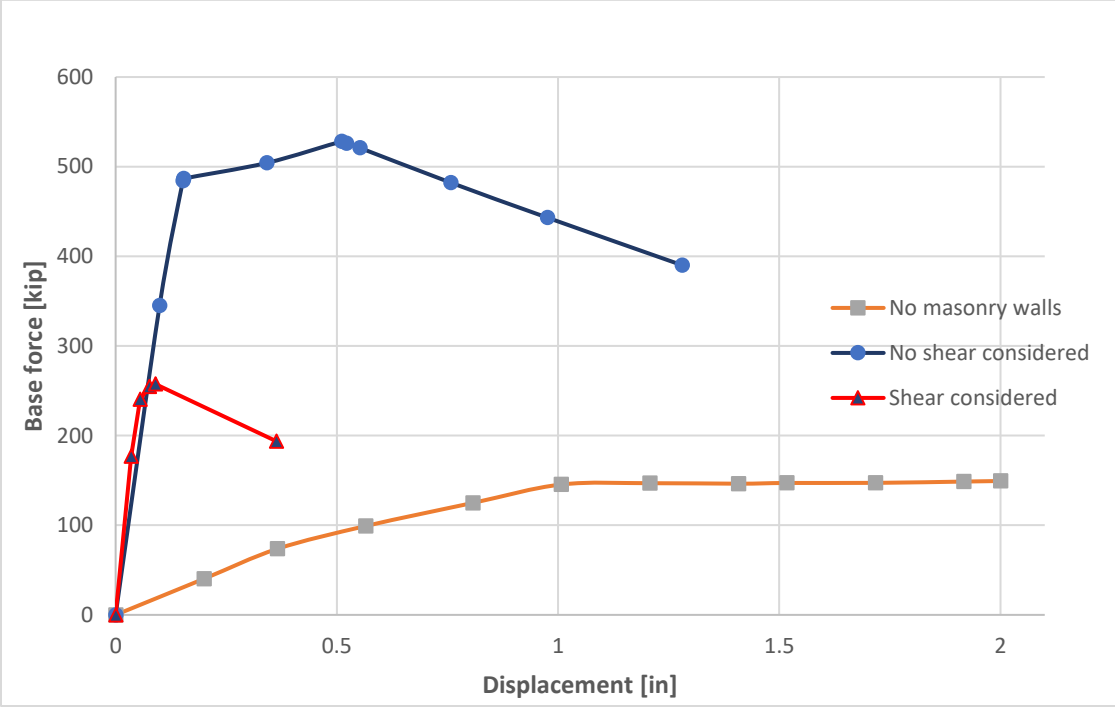
Figure 53. Pushover capacity curves of Frame I with and without shear - Case IV.

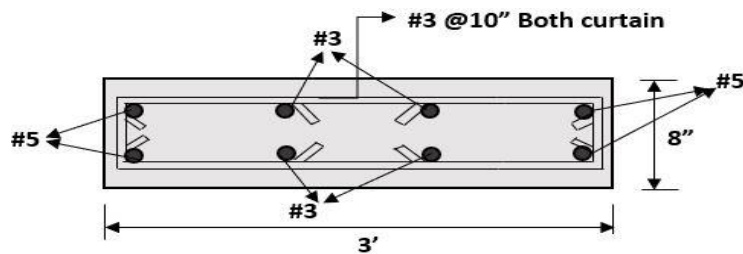
Figure 54. Reinforced concrete wall suggested for the rehabilitation strategy.

In 1997, Hassan and Sozen [23] studied the seismic vulnerability of low-rise buildings in regions with infrequent earthquakes based on observations made on a group of damaged buildings during the 1992 Erzincan, Turkey earthquake. According to the authors, buildings with a 0.5% or more wall percentage (walls area over total area from the top view) undergo negligible or no damages during earthquakes. Reinforced concrete walls are quite effective in resisting lateral load, also in terms of costs and application. These walls are commonly placed to stiffen the structure in its longitudinal direction, thus, attract more lateral load, and provide more capacity to the structure as they are reinforced, and therefore reduce the shear force that would be transmitted to the columns, which would reduce the possible effect of short column. Then, the reinforced concrete wall for the seismic rehabilitation system is 3 feet long and 8 inches wide. A RC wall segment will be placed at a selected position of each classroom. The RC wall must be extended from the foundation to the roof of the structure.

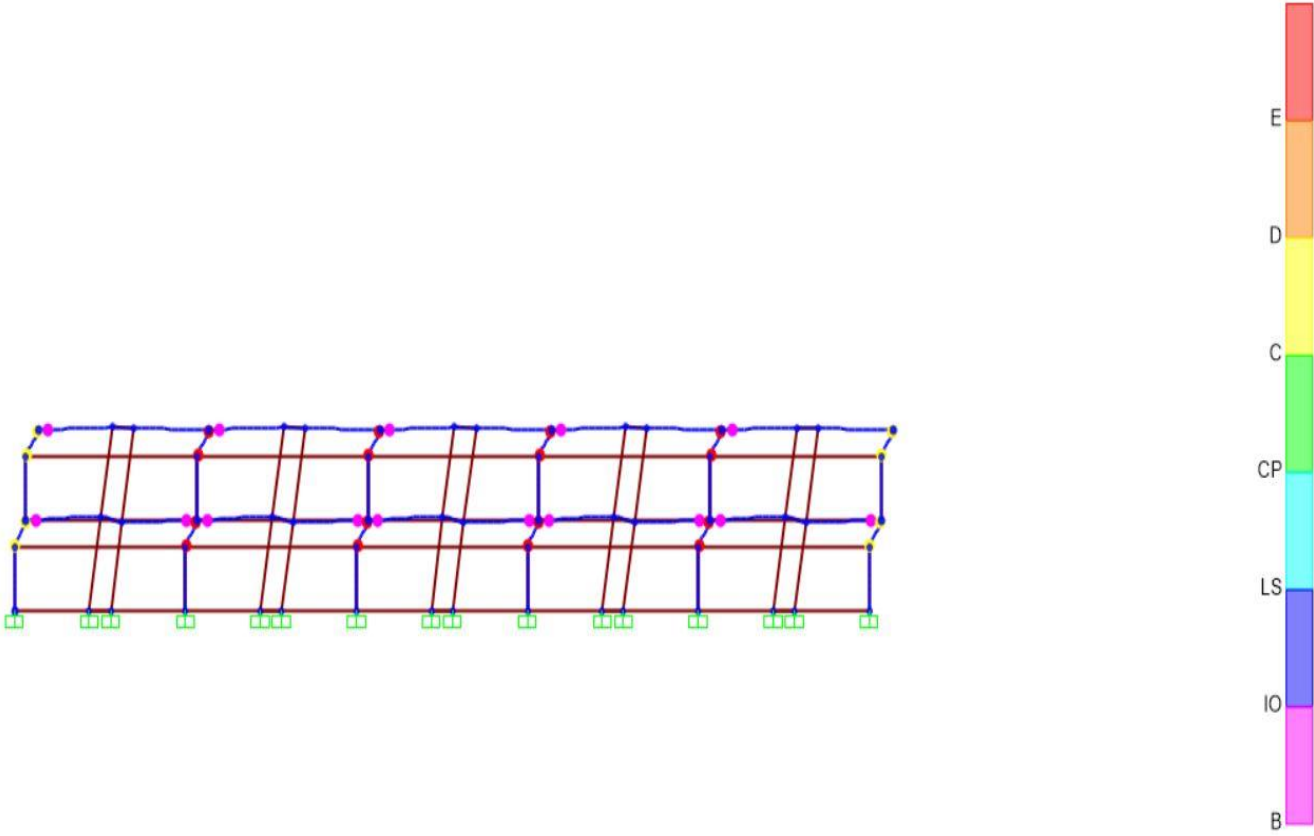
Figure 56. Sequence of plastic hinge formation – Case V.

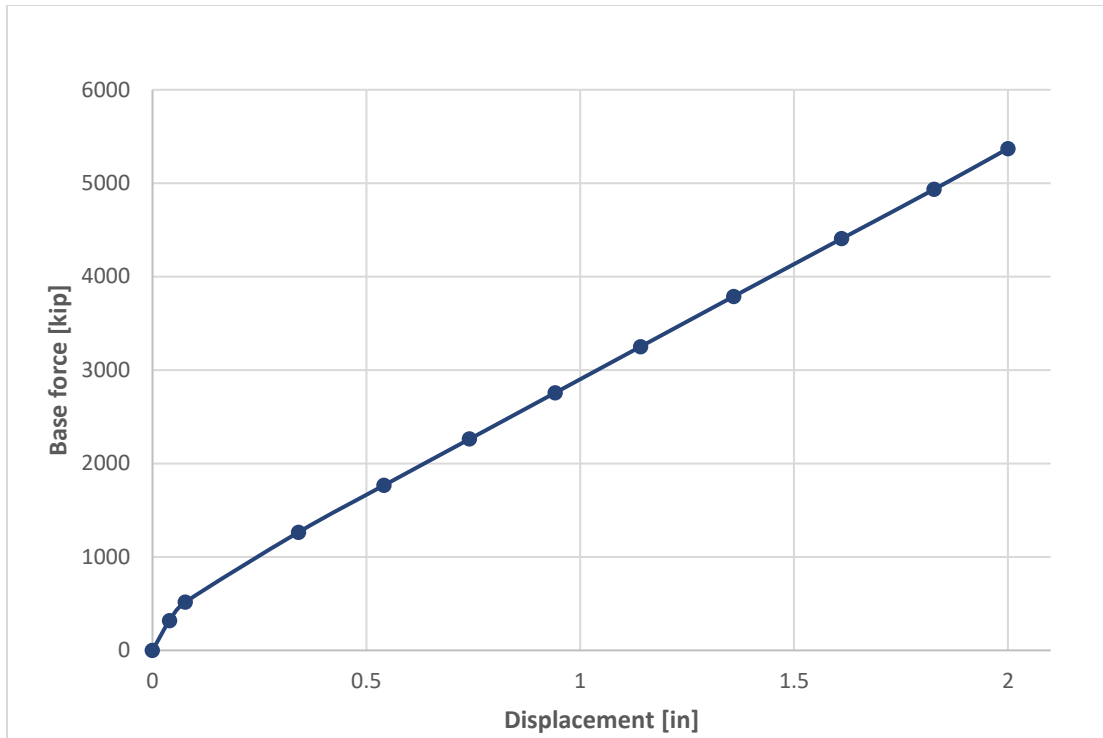
Figure 57. Pushover capacity curve of Frame I with the rehabilitation strategy inserted - Case V.

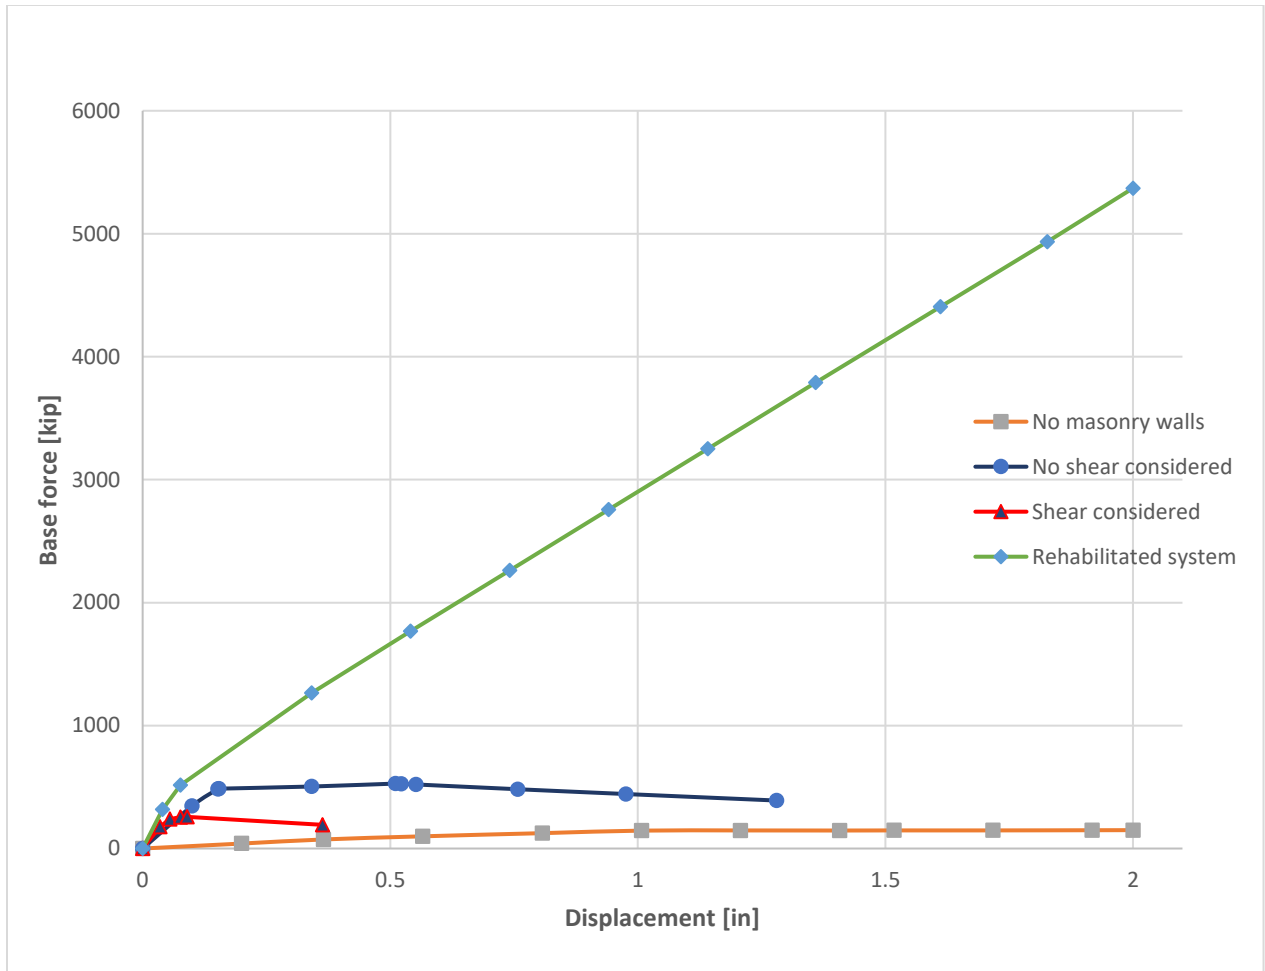
Figure 58. Pushover capacity curves for all the analyses performed on Frame I - Step VI

Figure 58 displays the base force vs displacement graph for all the Pushover analyses performed on Frame I, that includes the results of the Pushover performed on the frame with masonry walls with and without shear failures considered, and the results of the Pushover for the rehabilitation strategy selected. The reinforced concrete walls introduced to the system considerably increased the capacity of the structure and will carry most of the lateral load applied to the system. The results of the Pushover analysis with the rehabilitation strategy selected were quite satisfactory for the purpose of this research, as it allowed the structure to remain linear, and essentially, no shear failures of the columns was registered during the analysis.

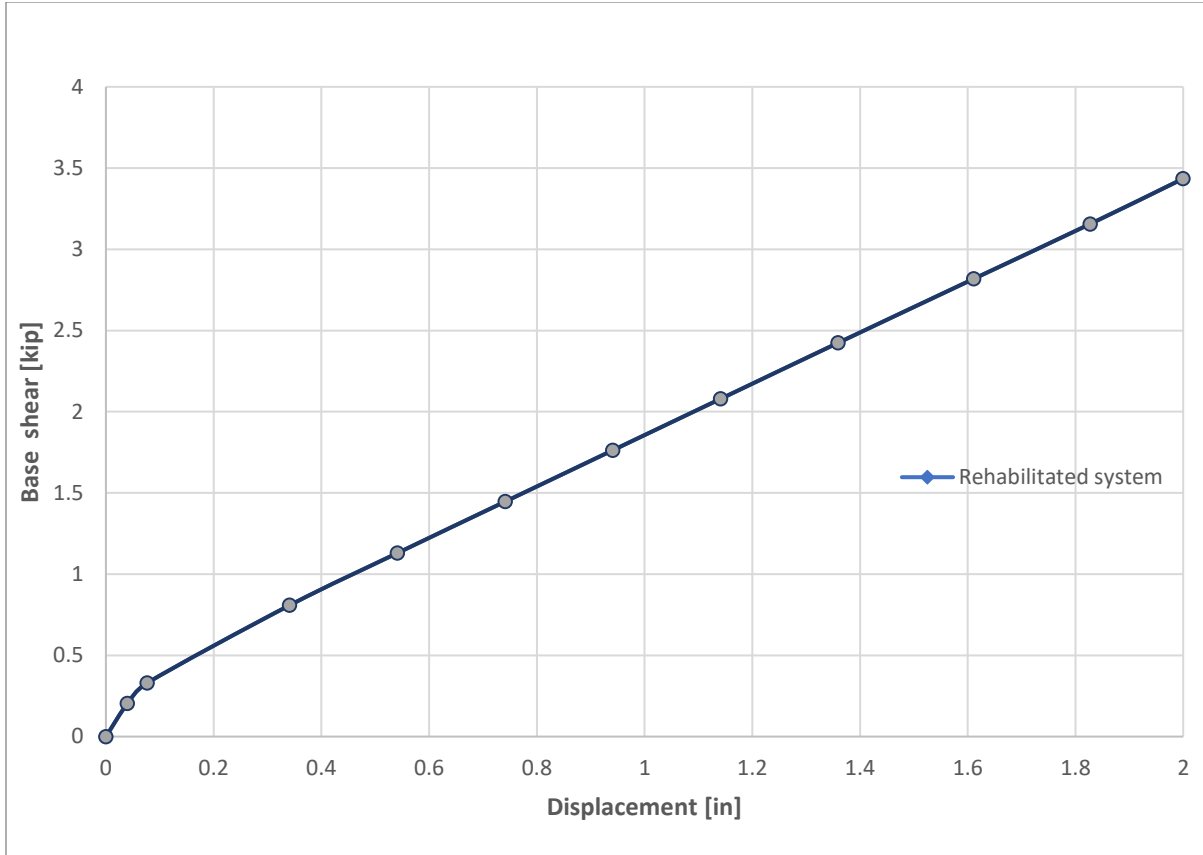
Figure 59. Pushover capacity curve of Frame I with the rehabilitation strategy inserted, when the base shear is divided by the total weight of module D.

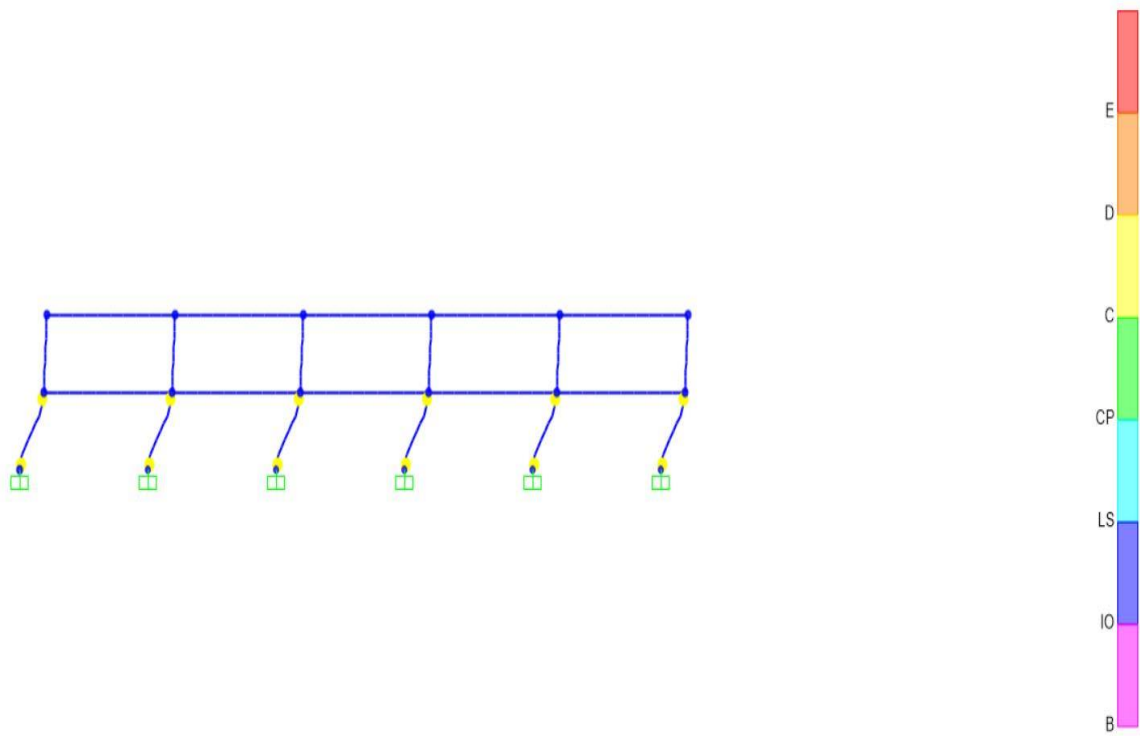
Figure 61. Sequence of plastic hinge formation – Case I.

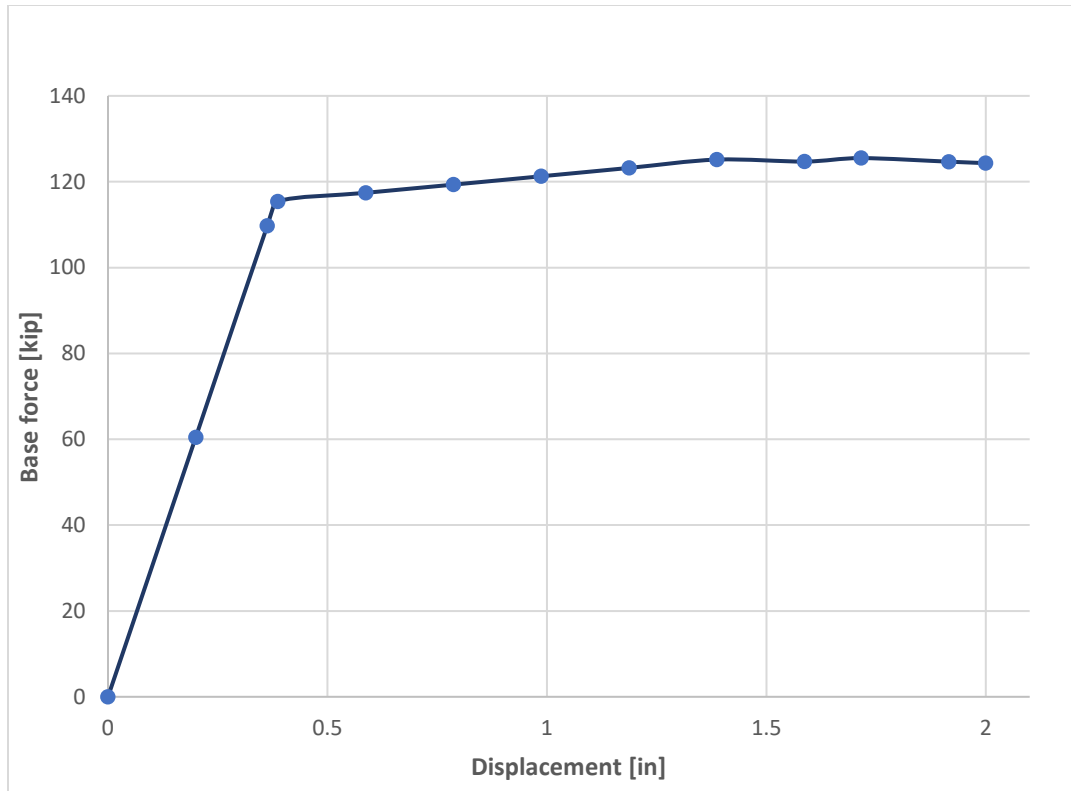
Figure 62. Pushover capacity curve of Frame II – Case I.

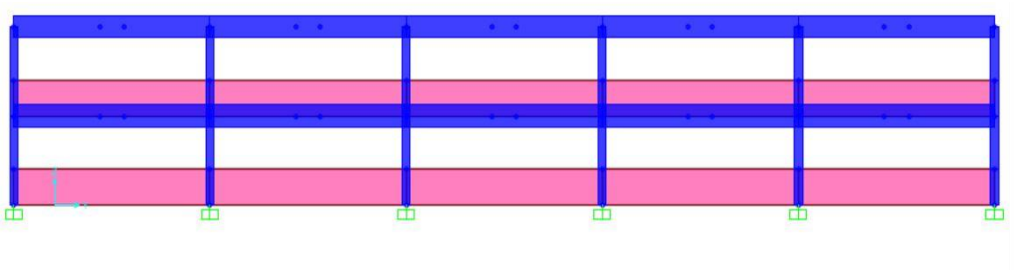
Figure 63. Frame II 2D model without masonry walls in the longitudinal direction in SAP2000.

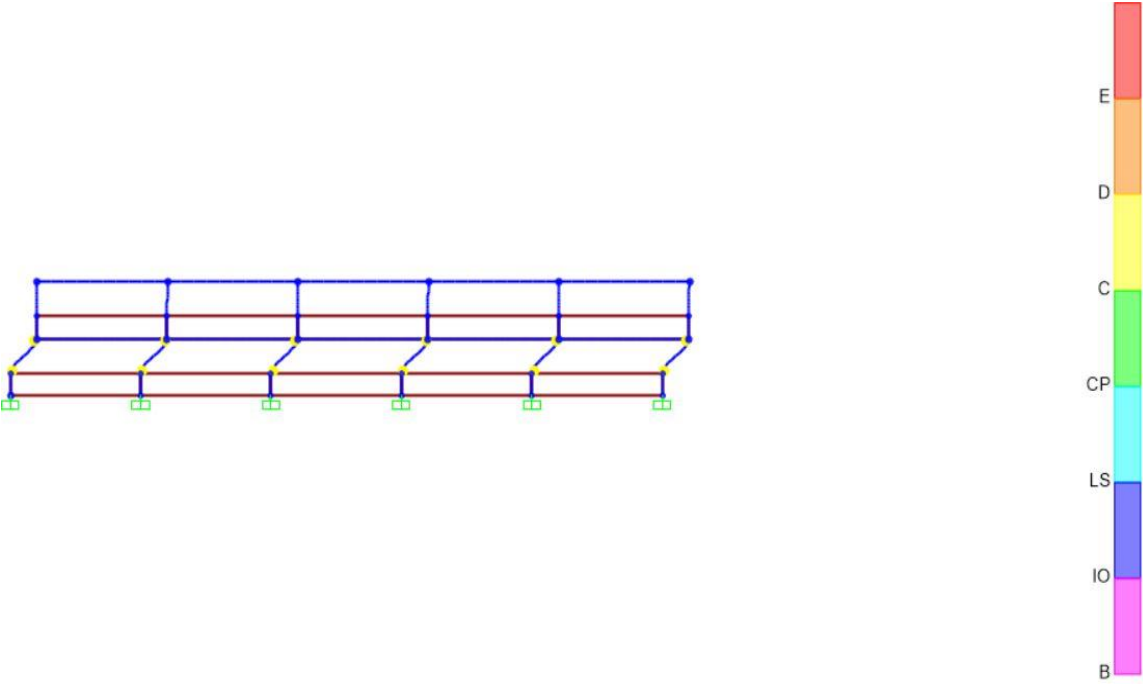
Figure 64. Sequence of plastic hinge formation – Case II.

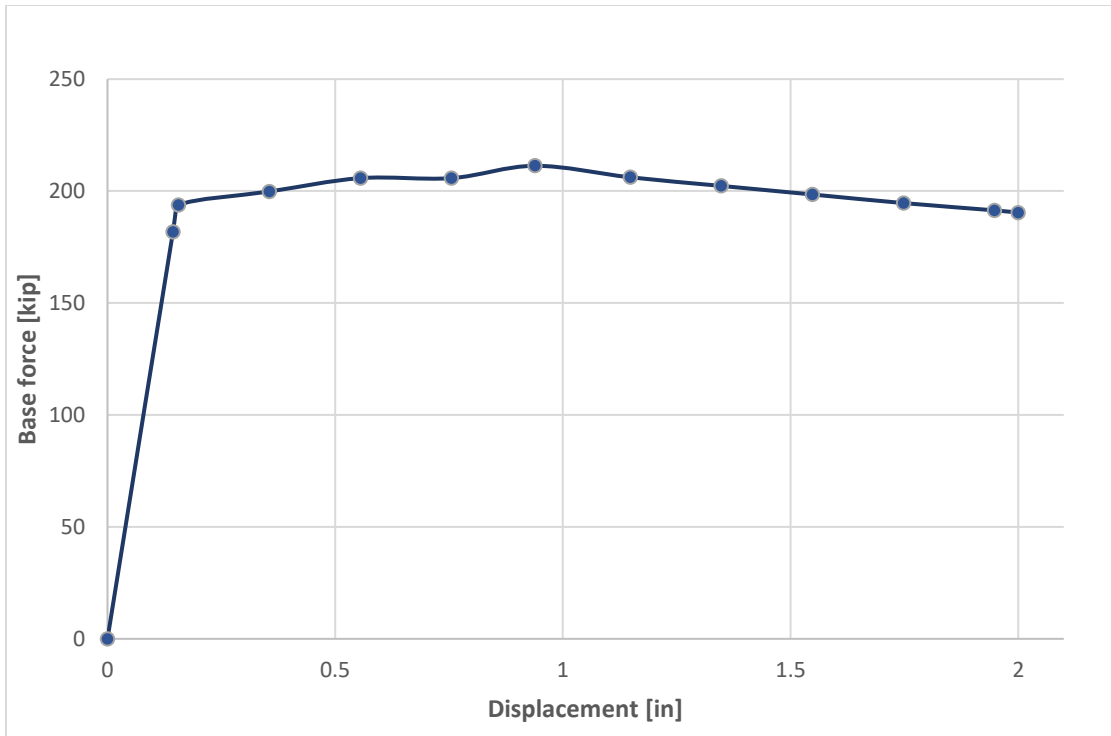
Figure 65. Pushover capacity curve of Frame II – Case II

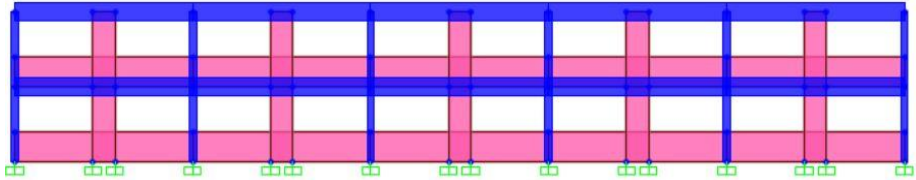
**Case III: Rehabilitation strategy: introduction of reinforced concrete walls to the structure.**

Figure 66. Frame I 2D model with the proposed rehabilitation strategy in SAP2000.

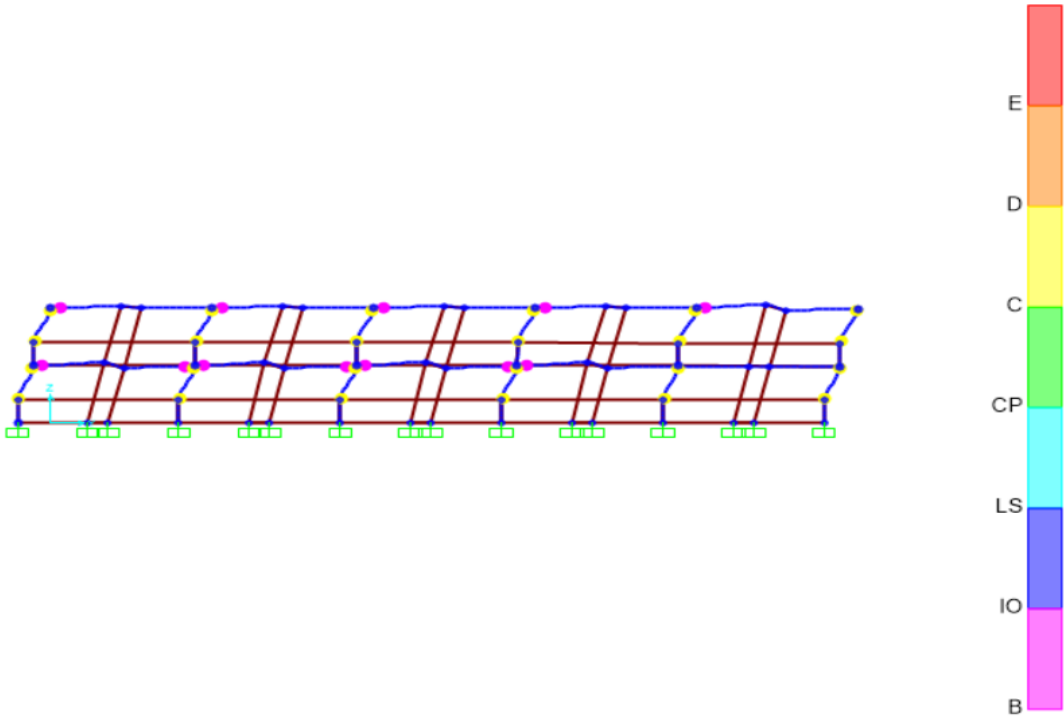
Figure 67. Sequence of plastic hinge formation – Case III.

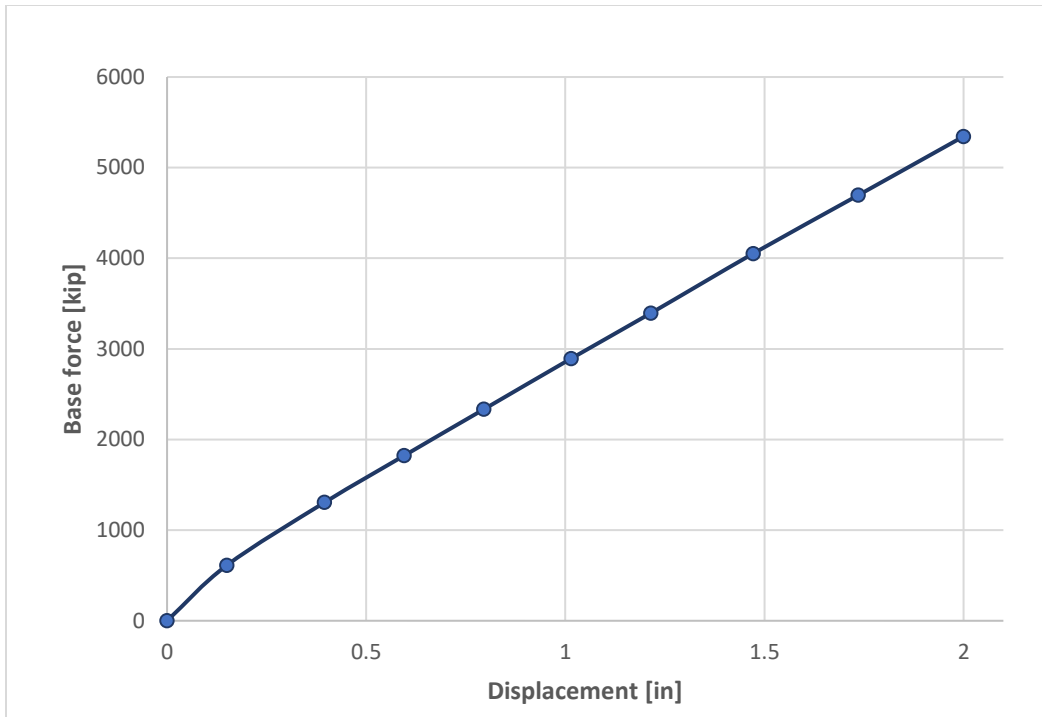
Figure 68. Pushover capacity curve of Frame I with the rehabilitation strategy inserted - Case III.

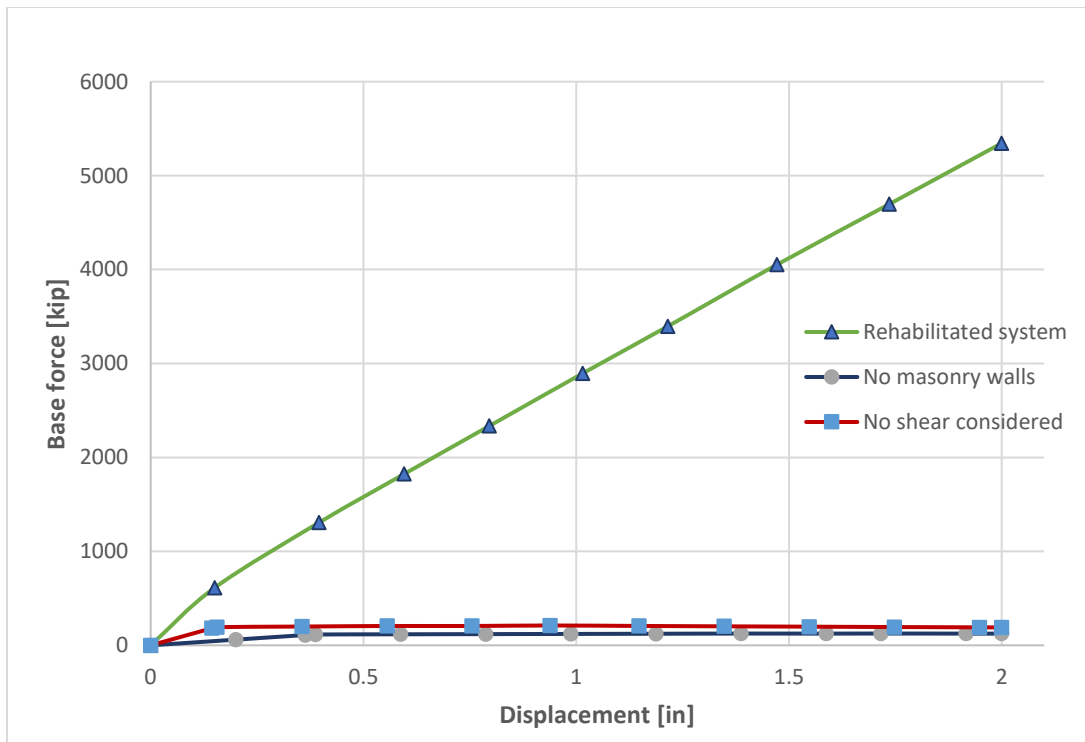
Figure 69. Pushover capacity curves for all the analyses performed on Frame II – Case IV

Since the rehabilitation strategy was not required for Frame II to assess the short column effect, the procedure became less complicated. The reinforced concrete walls will be inserted to preserve the geometric pattern to reduce the torsional effect. The capacity of the structure substantially increased from 211.3 kip to 5344.5 kip.

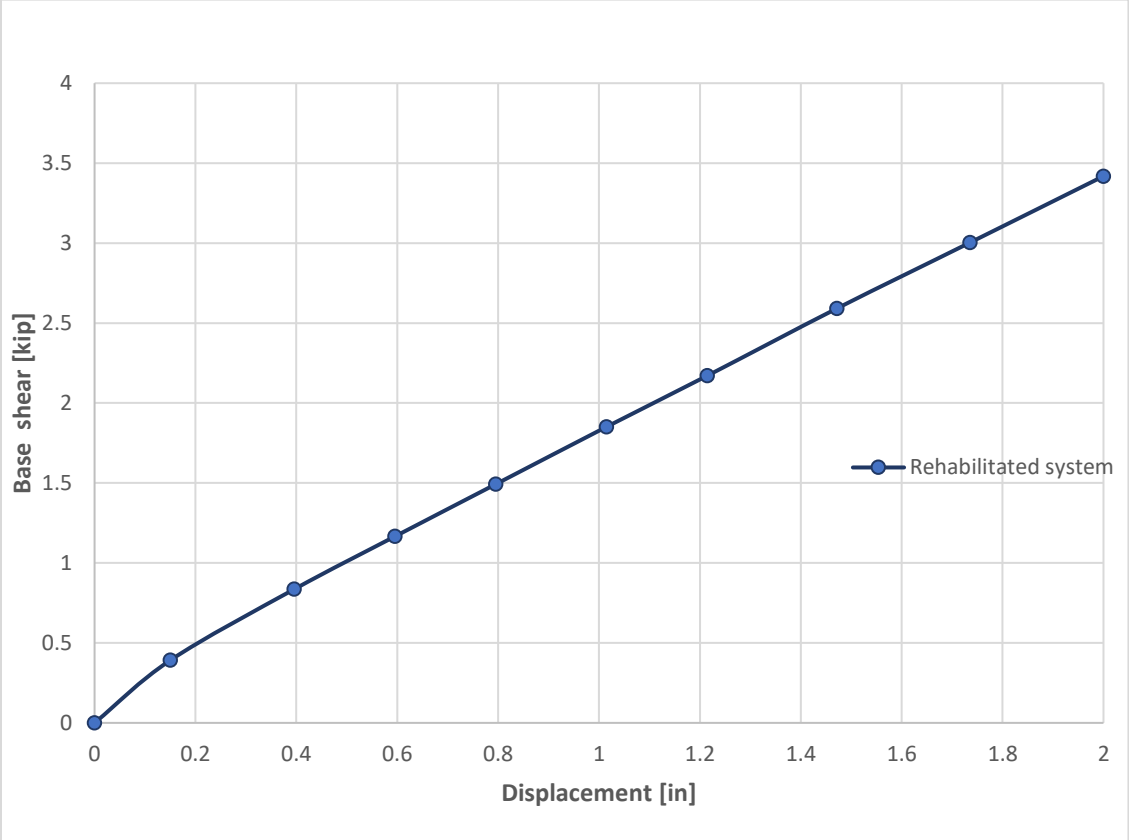
Figure 70. Pushover capacity curve of Frame II with the rehabilitation strategy inserted, when the base shear is divided by the total weight of module D.

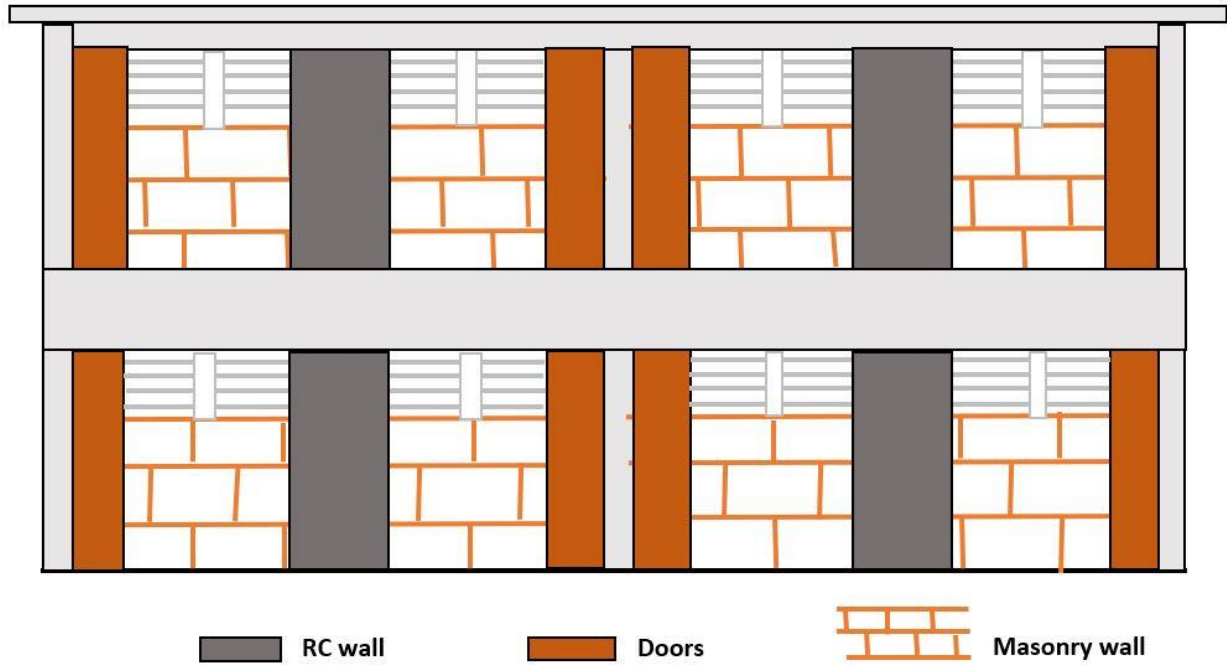
Figure 71. Front view of the selected module of typical school building in Puerto Rico with the suggested RC walls – Frame I.

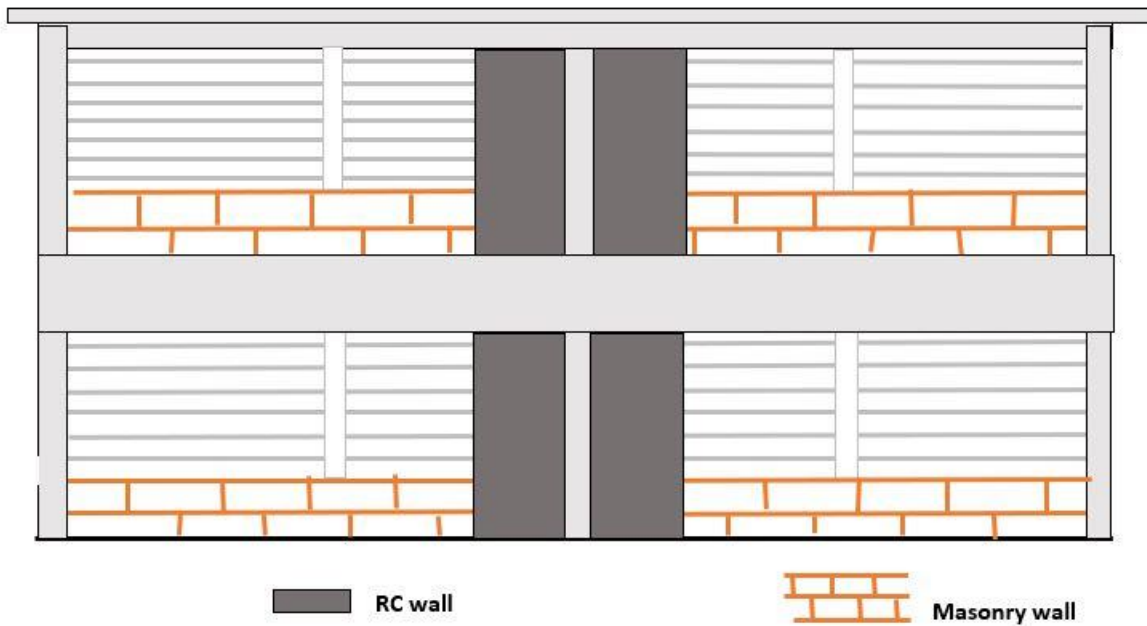
Figure 72. Back view of the selected module of typical school building in Puerto Rico with the suggested RC walls – Frame II.

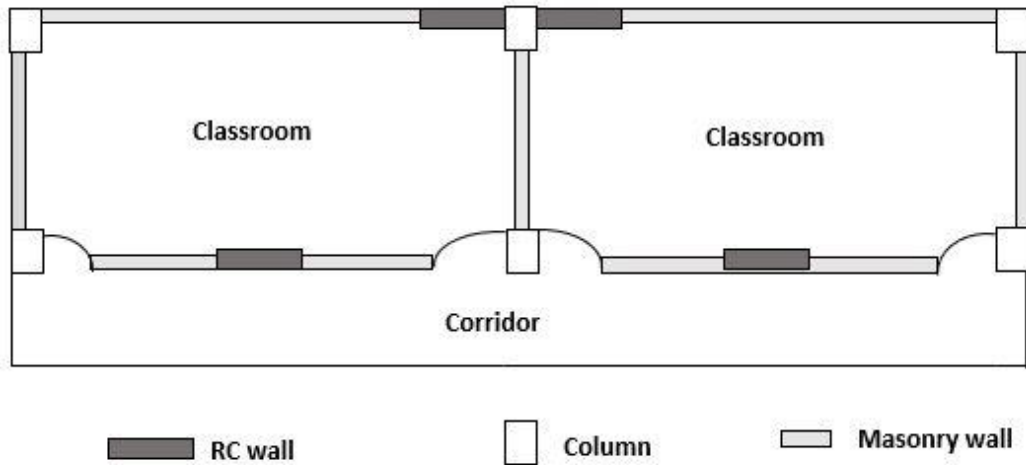
Figure 73. Top view of the selected module of a typical school building in Puerto Rico with the suggested RC walls.

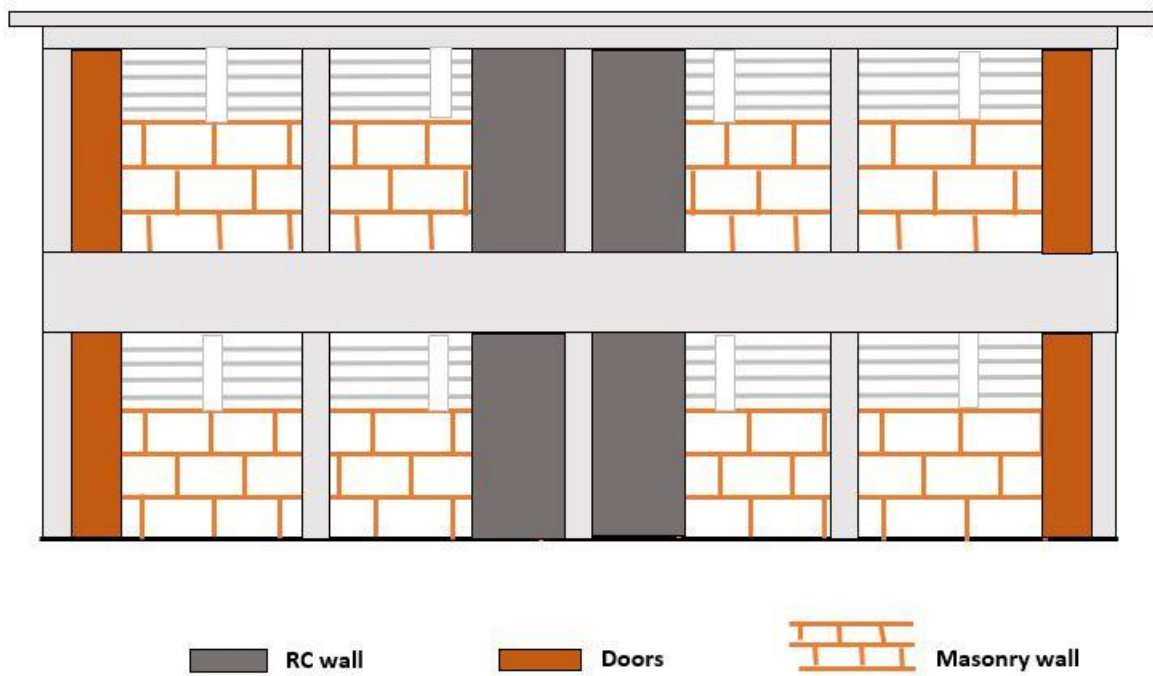
Figure 74. Front view of another module of a typical school building in Puerto Rico with the suggested RC walls – Frame I.

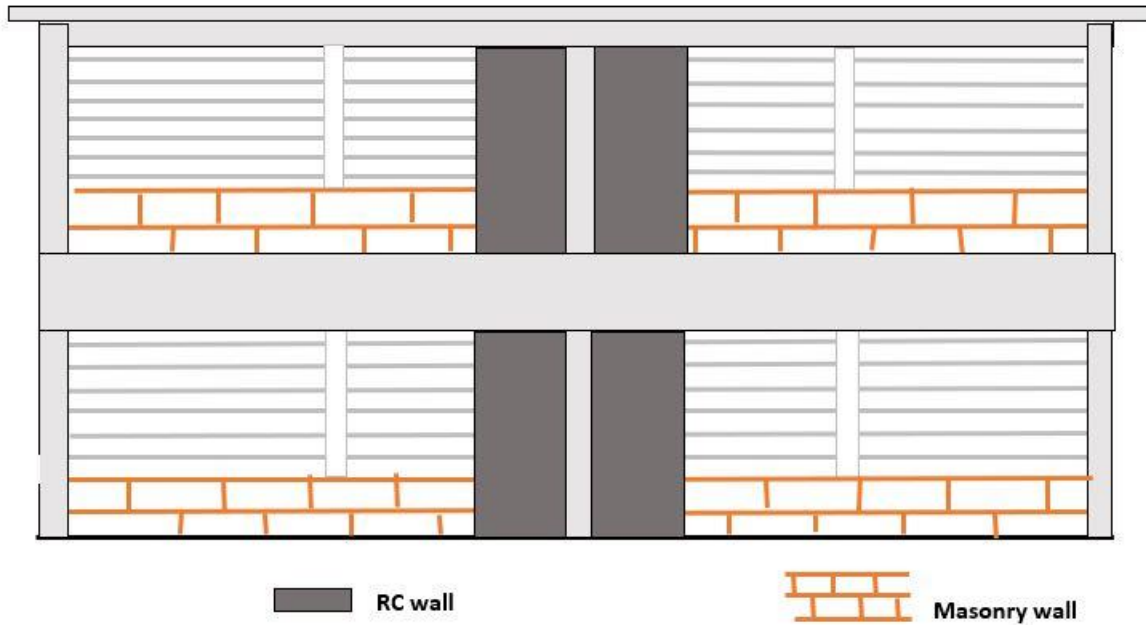
Figure 75. Back view of another module of a typical school building in Puerto Rico with the suggested RC walls – Frame II.

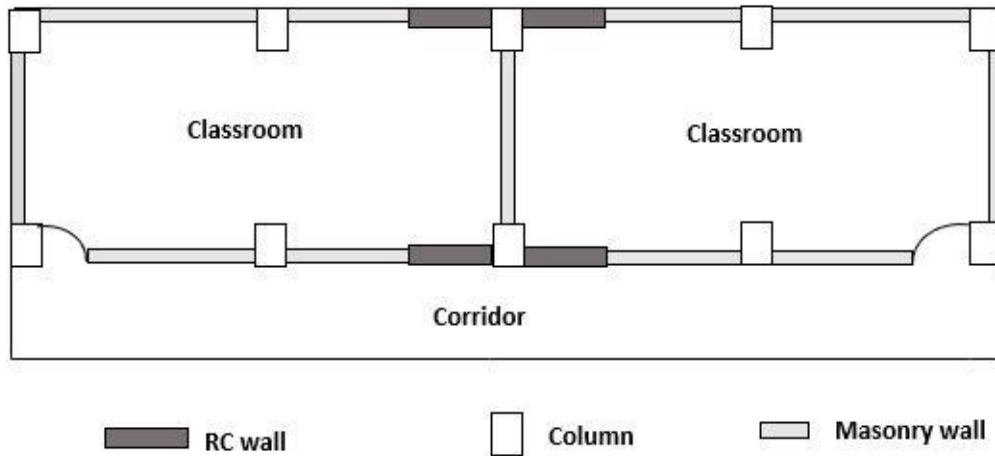
Figure 76. Top view of another module of a typical school building in Puerto Rico with the suggested RC walls.

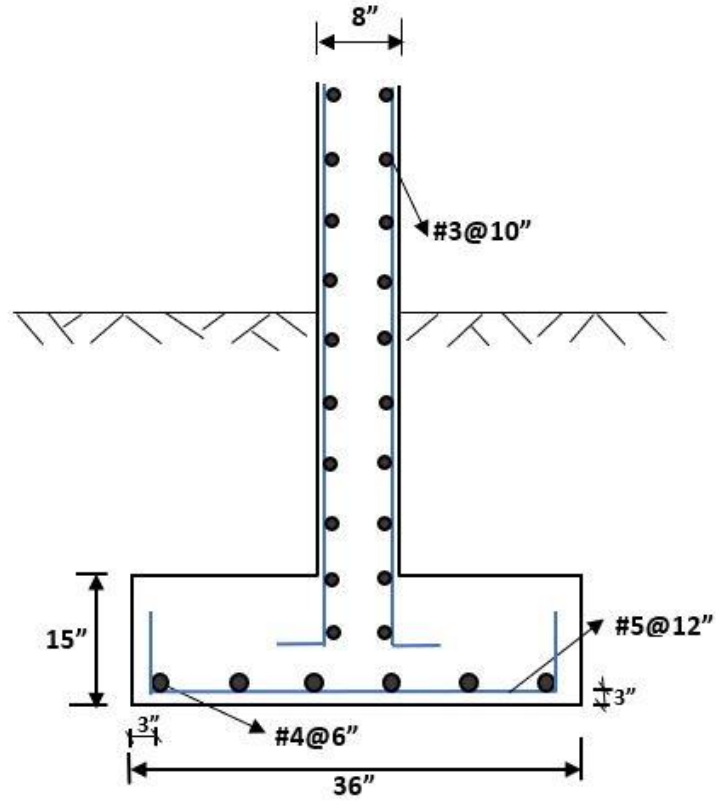
Figure 77. Recommended foundation for the suggested RC walls

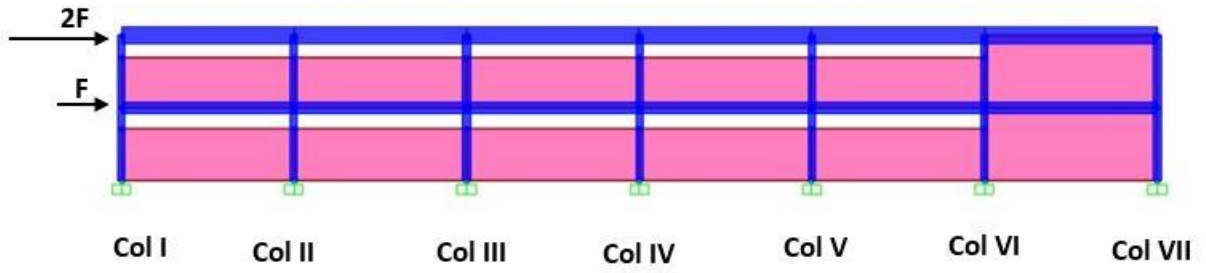
Figure 79. Frame I 2D model in SAP2000.

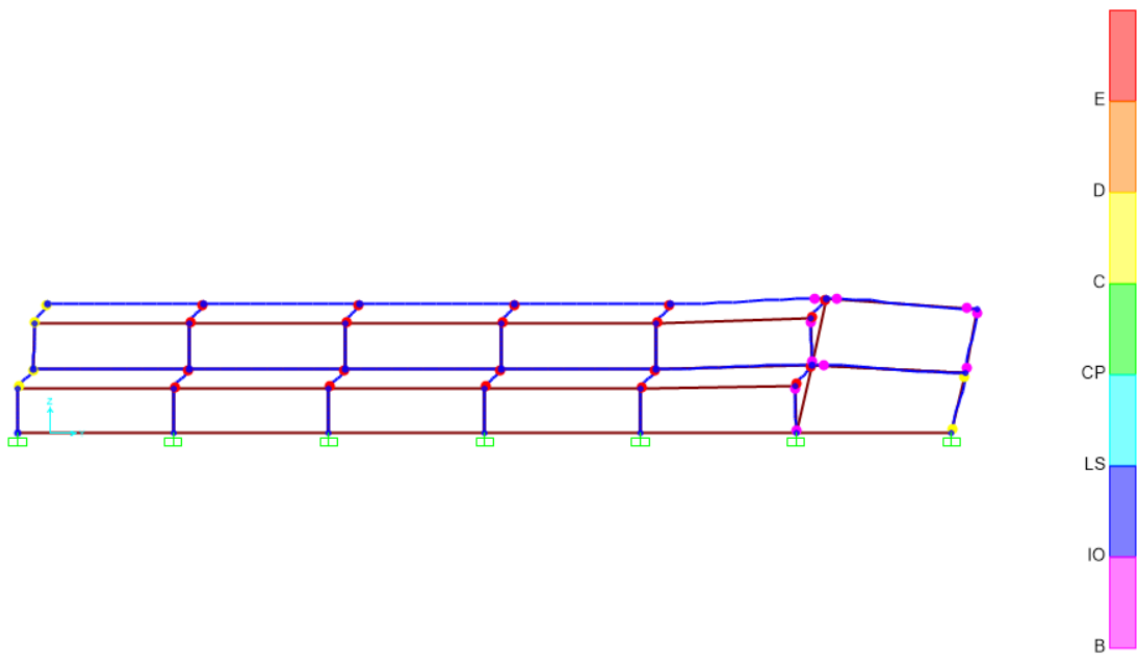
Figure 80. Sequence of plastic hinge formation.

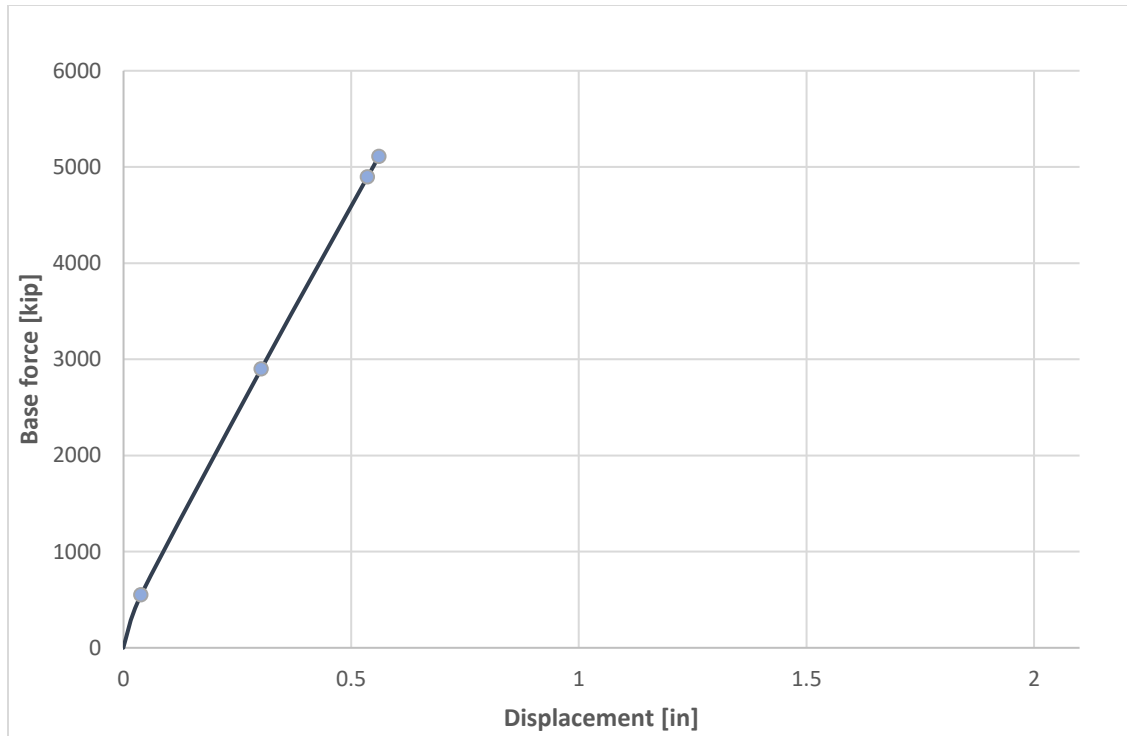
Figure 81. Pushover capacity curve of Frame I Module D with bathrooms inserted in SAP2000.

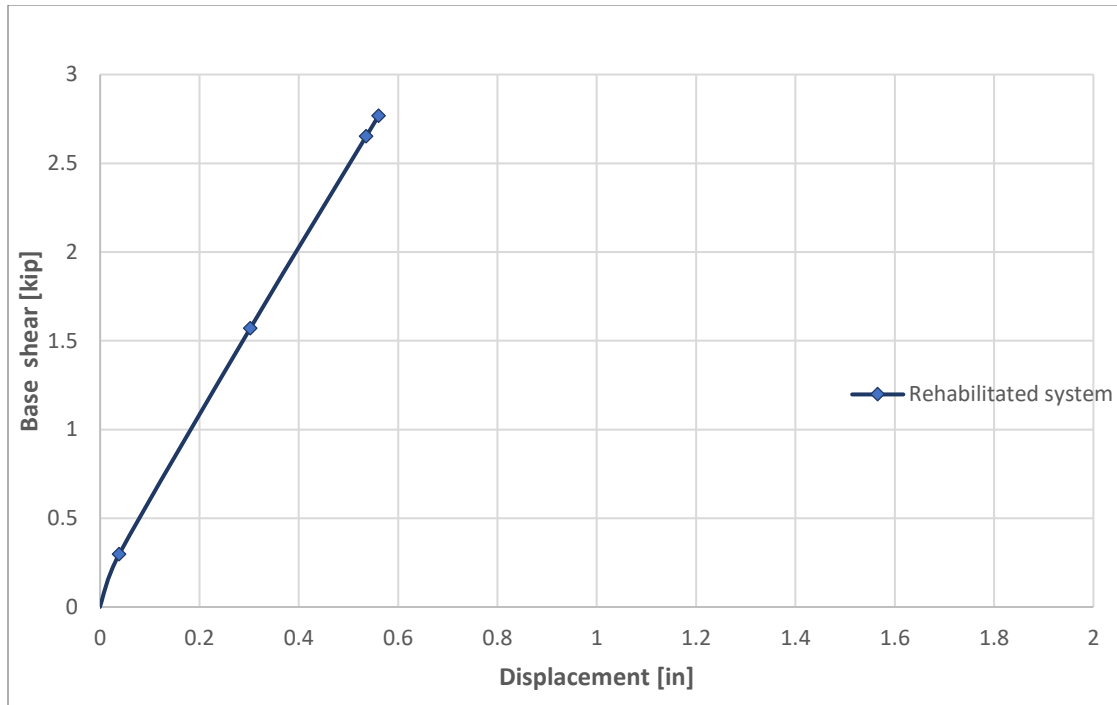
Figure 82. Pushover capacity curve of Frame I with bathrooms inserted in SAP2000, when the base shear is divided by the total weight of module D.
