# SEISMIC REHABILITATION OF TYPICAL SCHOOLS IN PUERTO RICO

MASTER OF ENGINEERING  
IN  
CIVIL ENGINEERING

UNIVERSITY OF PUERTO RICO  
MAYAGÜEZ CAMPUS

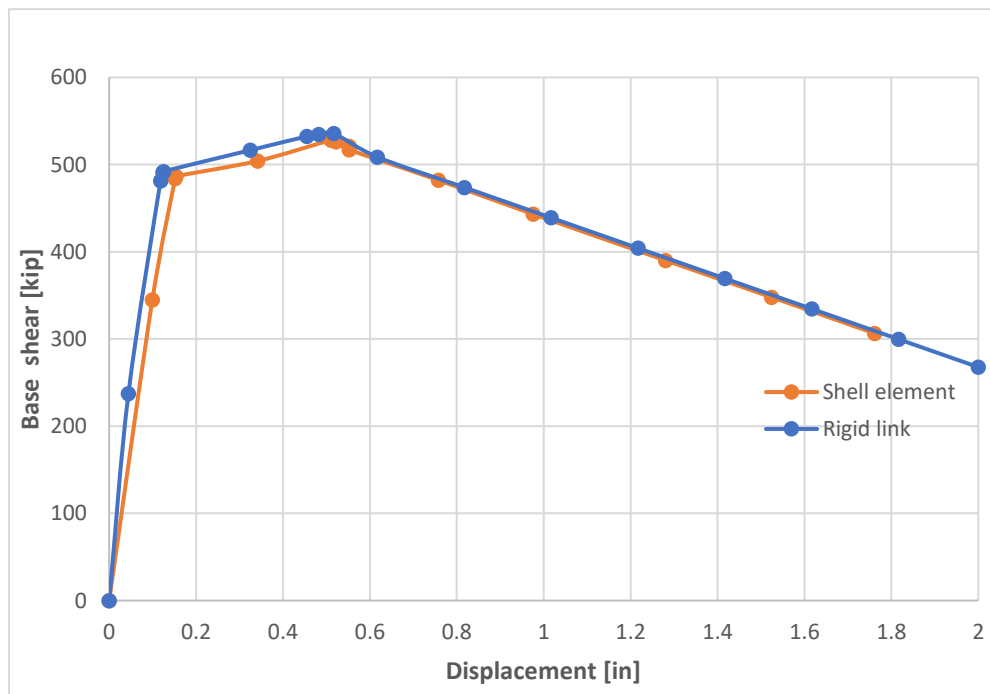
Figure 86. Pushover capacity curves using shell element vs rigid link of Frame I – Case I

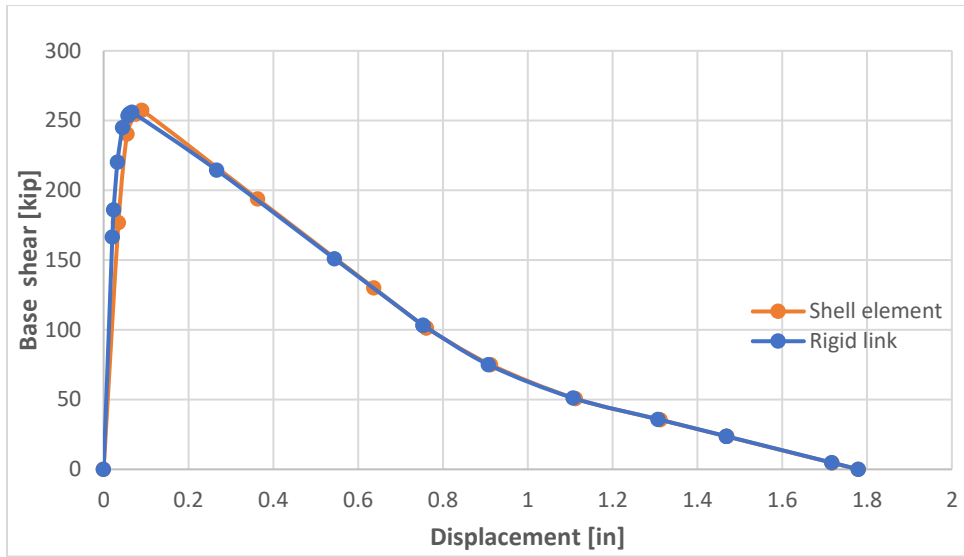
Figure 87. Pushover capacity curves using shell element vs rigid link of Frame I – Case II

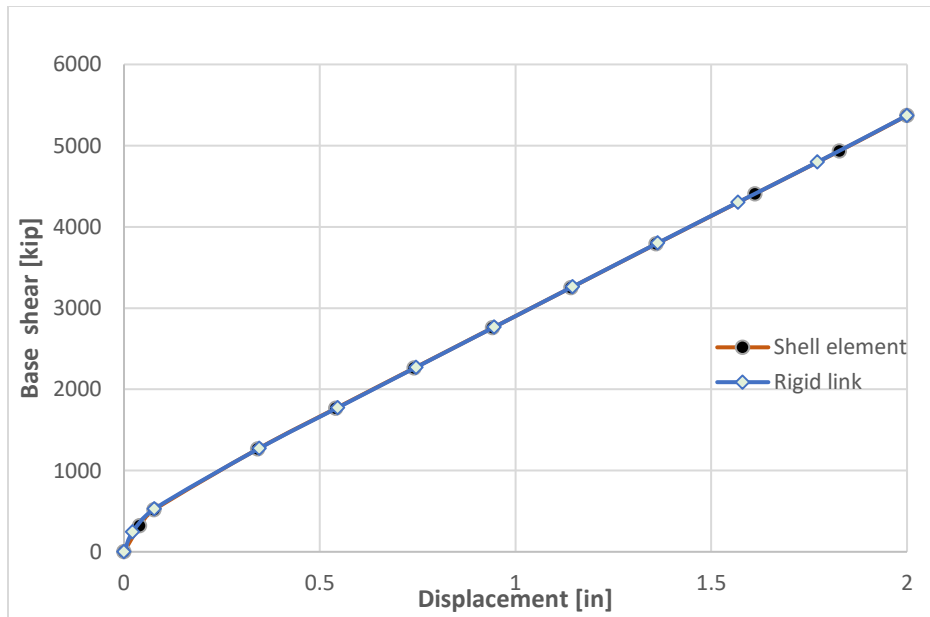
Figure 88. Pushover capacity curves using shell element vs rigid link of Frame I – Case III
