## Coastal Erosion Assessment Using Small Unmanned Aerial Vehicles (UAVs) and Numerical Modeling: A Case Study in the Western Region of Puerto Rico

A thesis submitted in partial fulfillment of the requirements for the degree of

## UNIVERSITY OF PUERTO RICO MAYAGÜEZ CAMPUS

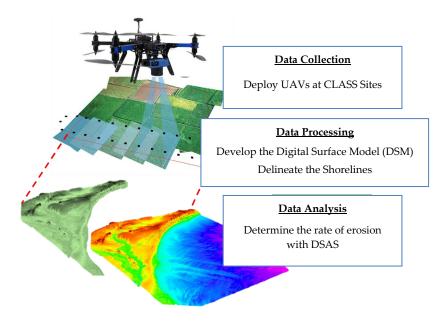
Figure 3-2. UAV Workflow

This section will be divided into: data collection, data processing, and data analysis in order to explain the UAV methodology (Figure 3-2).

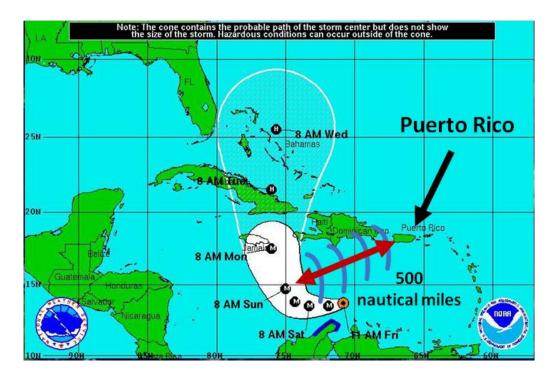
Figure 3-4. Hurricane Matthew trajectory (NOAA)

In October 2016, UAVs were deployed to perform a rapid assessment and evaluate the effects of the Hurricane Matthew (Category 4) at Rincón, PR. This hurricane was 500 nautical miles away and the southwestern direction of the generated swell severely impacted the western region of Puerto Rico (Figure 3-4).

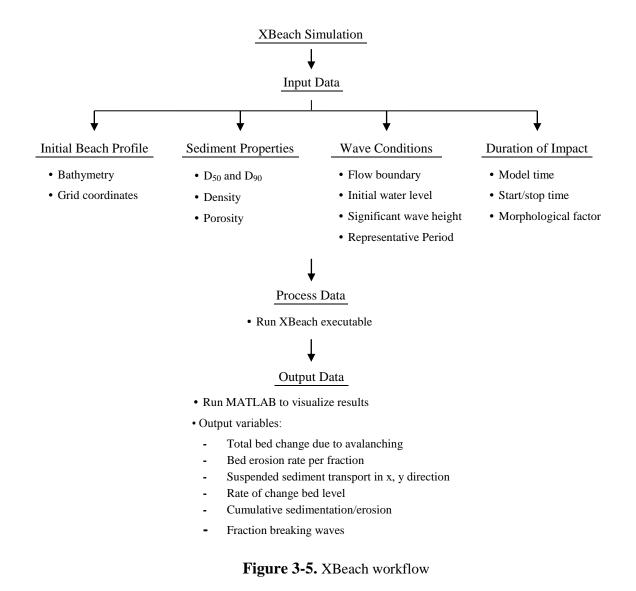
Figure 3-5 shows the workflow implemented in the numerical simulation.

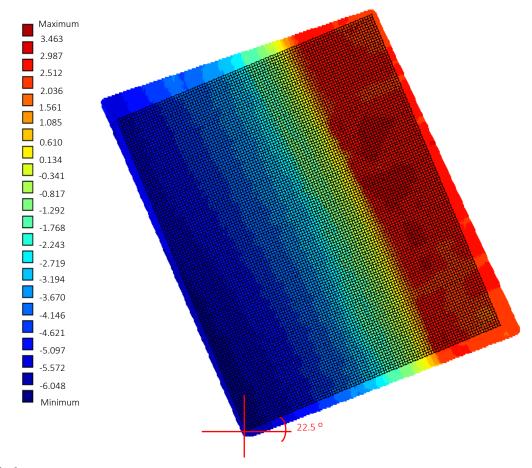
**Figure 3-6.** USACE topo-bathy LiDAR data and Delft3D grid (2-meter resolution in *x*- and *y*- direction) used for the XBeach simulation

imager on a single remote sensing platform. The horizontal positions were referenced to the NAD83 HARN SPCS for Puerto Rico and Virgin Islands FIPS 5200 with 1-meter resolution. The vertical positions were referenced to the PRVD02 with a vertical accuracy of 0.01 meters. This data was used to establish the model computational domain that defines the area of interest for the modeling (Figure 3-6). The grid was generated with a 2-meter resolution using ArcGIS and Delft3D software and was aligned parallel to the coastline with 22.5 degrees of inclination. The elevation values for the study area were from 3.45 to -6.05 meters; negative values correspond to the bathymetry data portion.

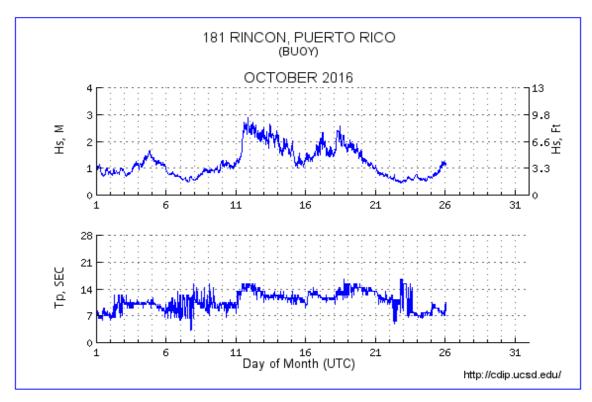
Figure 3-8. CARICOOS buoy data at Rincón, P.R (The Coastal Data Information Program)

In addition to the topo-bathymetry data, wind, wave, and tide data generated during the Hurricane Matthew event were also needed. Wind and wave data were obtained from the Caribbean Coastal Ocean Observing System (CARICOOS) Rincón wave buoy and anemometer, respectively (Figures 3-7 and 3-8). Tide data was obtained from the NOAA tidal station at Mayaguez, P.R (Figures 3-7 and 3-9) (NOAA 2018); values are shown in Table 3-2 and 3-3.

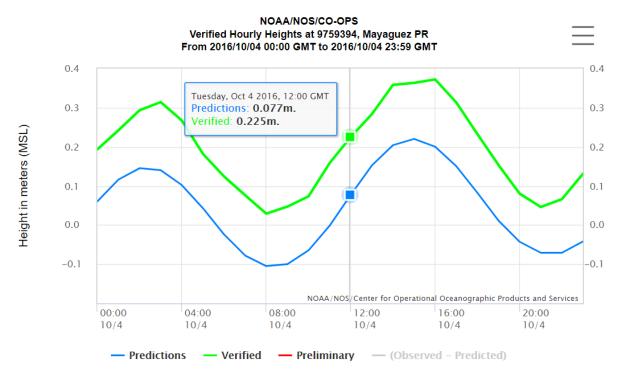
Figure 3-9. NOAA tide/water levels data for October 4, 2016

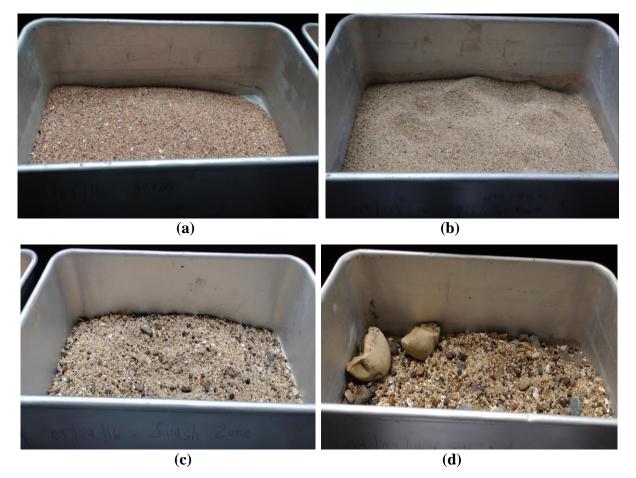
Figure 3-10. Samples collected from (a) berm; (b) beach face; (c) swash zone; and (d) nearshore

The uniform  $D_{50}$  sediment diameter and  $D_{90}$  diameter were needed for the XBeach simulation. Both diameters were obtained through the characterization of the soil conducting the sieve analysis test using the Standard of the American Society for Testing and Materials ASTM-C136. Samples were collected on September 4th, 2016 as part of a thesis project lead by Professor Miguel Canals. The samples were collected from four different areas: (a) berm, (b) beach face/front, (c) swash zone, and (d) nearshore (Figures 3-10 and 3-11). These four areas were selected to obtain a clearly idea of the sediments found on the beach.

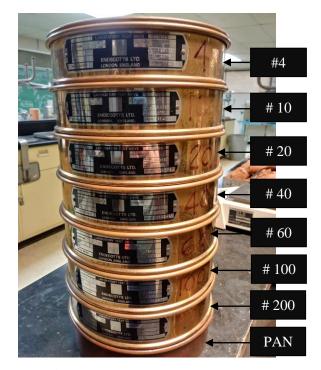
Figure 3-12. Sieve size sequence

In order to perform the sieve analysis, the sequence of sieves shown in Figure 3-12 was used.

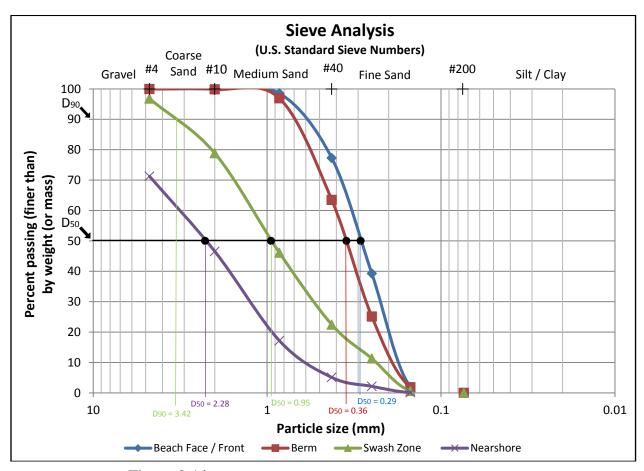
Figure 3-14. Sieve analysis graph for the four samples collected

Figure 3-14 shows the sieve analysis results for the four collected samples. This graph was generated using the sieve size and passing percent data from each collected sample. These results were used to determine the diameters  $D_{50}$  and  $D_{90}$  of each sample. Results are summarized in Table 3-8, in addition to the average diameter results of the four samples needed for the XBeach simulation.

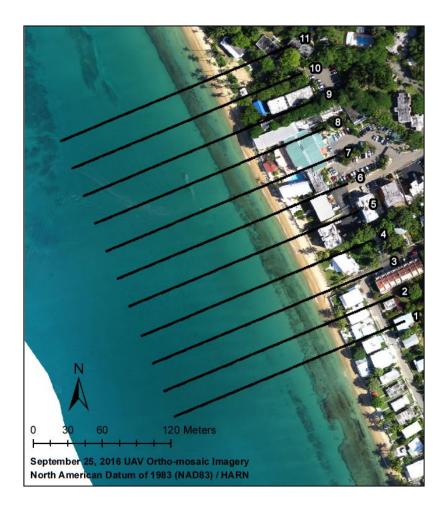
Figure 3-15. Transect used for the profiles creation

XBeach simulation results were managed using MATLAB and Microsoft Office Excel. Eleven transects were cast perpendicular to the coastline with 10 meters spacing (Figure 3-15). Erosion and accretion results were added to the initial bed level results to develop the simulated bed level.

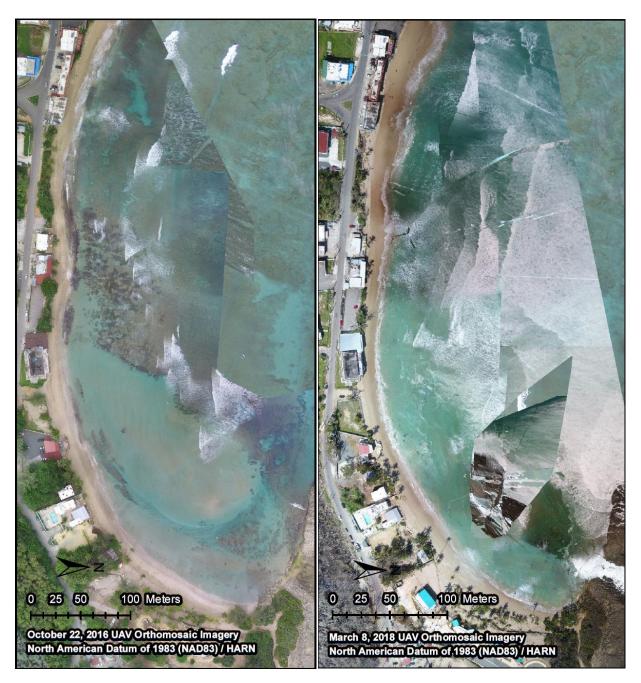
Figure 4-16. Ortho-mosaic images from 2016 and 2018 for Jobos Beach, Isabela

Ortho-mosaics were developed for Jobos Beach at Isabela, Crash Boat Beach at Aguadilla, and Cofresí Beach at Rincón as shown in Figures 4-16 to 4-18. These images were projected using the NAD83 HARN SPCS for Puerto Rico and Virgin Islands FIPS 5200 in meters and generated for years 2016 and 2018 with a 2.05 centimeter/pixel resolution. The ortho-mosaic images had an approximately extension of 0.6 kilometers for Jobos Beach at Isabela, 0.5 kilometers for Crash Boat Beach at Aguadilla, and 0.3 kilometers for Cofresí Beach at Rincón.

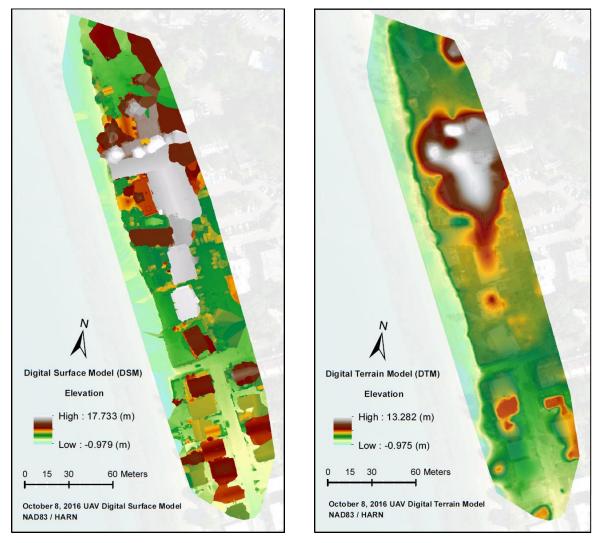
Figure 4-19. DSM and DTM of Cofresí Beach, Rincón

A DSM and DTM were developed for the validation of the XBeach simulation at Cofresí Beach, Rincón (Figure 4-19). Both models were generated in 2016, after the Hurricane Matthew with a 2.05 centimeter/pixel resolution. These models were projected using the NAD83 HARN SPCS for Puerto Rico and Virgin Islands FIPS 5200 in meters. The DSM from the Sea Grant project R/75-1-14 was also used.

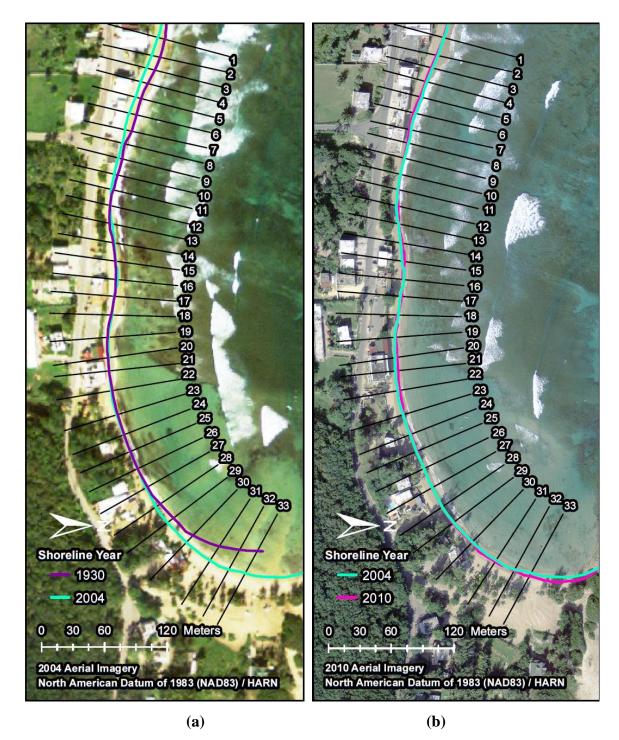
Figure 5-20. Shoreline changes at Jobos Beach, Isabela for periods (a) 1930-2004 and (b) 2004-10

The analysis of the historical shoreline positioning maps for Jobos Beach at Isabela, for the periods from 1930 to 2004 (Figure 5-20a), showed retreat events. This could be due to the conditions generated during several meteorological events that have occurred in that period. During the period from 2004 to 2010 (Figure 5-20b), the shoreline remained almost in the same position, except for a few small segments. It is important to recognize that the delineation of the coast varies over time and is influenced by the waves and tides. Similarly, for the period from 2010 to 2016 (Figure 5-21a), the shoreline remained almost in the same position, with the exception of some areas that showed retreat. For the period from 2016 to 2017 (Figure 5-21b), the coastline had a significant setback. Taking into account the past periods, this beach did not present problems of retreat in the coastline, until Hurricane Maria (Category 4) event on September 20, 2017 which directly impacted the complete island of Puerto Rico. On September 21, 2017 CARICOOS buoy measured waves with a maximum significant wave height of 6.40 meters, 12 seconds peak period and peak wave direction of 290°. This event completely altered the trend of the coastline at Jobos Beach at Isabela. For the period from 2017 to 2018 (Figure 5-22a), the coastline recovered in large part compared to its initial position before Hurricane Maria. The comparison of the period from 1930 to 2018 (Figure 5-22b), showed mild erosion in some transects.

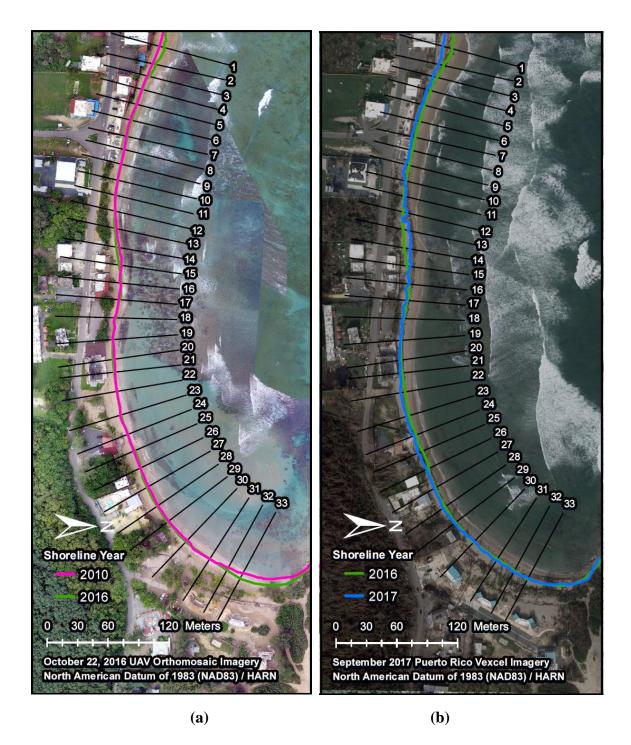
Figure 5-21. Shoreline changes at Jobos Beach, Isabela for periods (a) 2010-16 and (b) 2016-17

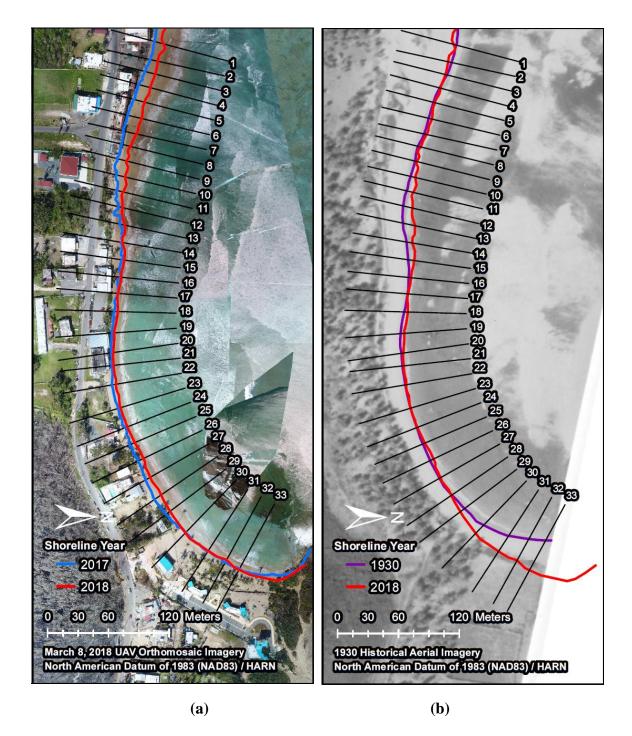
Figure 5-22. Shoreline changes at Jobos Beach, Isabela for period (a) 2017-18 and (b) net shoreline change from 1930 to 2018

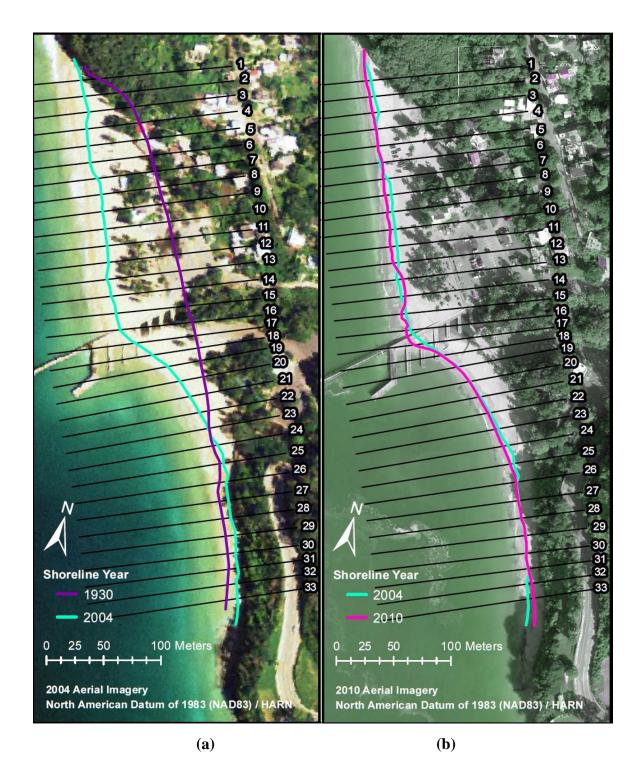
Figure 5-23. Shoreline changes at Crash Boat Beach, Aguadilla for periods (a) 1930-2004 and (b) 2004-10

The analysis of the historical shoreline positioning maps for Crash Boat Beach at Aguadilla, for the period from 1930 to 2004 (Figure 5-23a), presented a recovery in the coastline. This behavior was due to the construction of a pier / dock for the Ramey Air Force Base. For the period from 2004 to 2010 (Figure 5-23b), the coastline also presented a recovery similarly for the period from 2010 to 2016 (Figure 5-24a). A possible caused for the accretion could be to the sediment transport by means of the swell. For the period from 2016 to 2017 (Figure 5-24b), the coastline had a significant retrieve. Based on the digitized coastline, the beach was completely lost as a result of Hurricane Maria. Similar to Jobos Beach, this beach did not showed retrieve events along the coastline until the impact of Hurricane Maria. For the period from 2018 (Figure 5-25a), the coastline presented a recovery due to the onshore sediment transport induced by the waves. Considering the period of 1930 and 2018 (Figure 5-25b), the beach has had a change in its entirety.

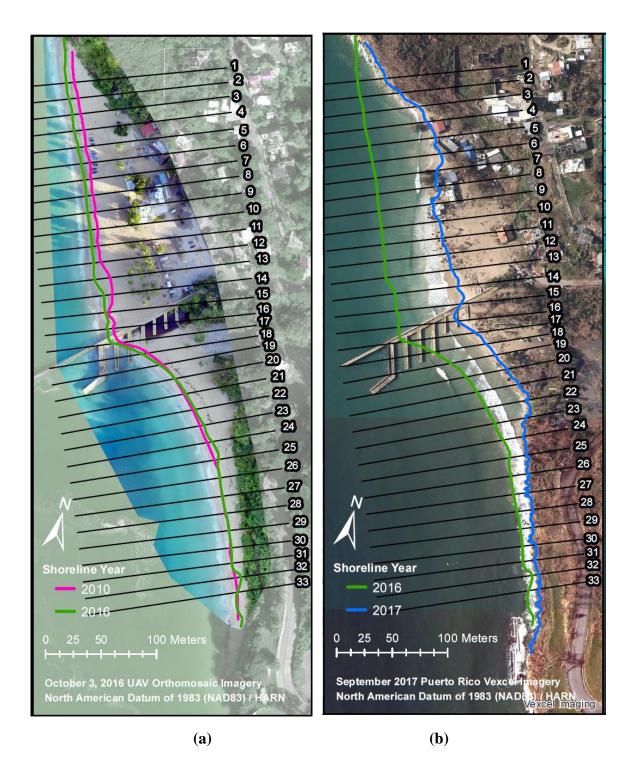
Figure 5-24. Shoreline changes at Crash Boat Beach, Aguadilla for periods (a) 2010-16 and (b) 2016-17

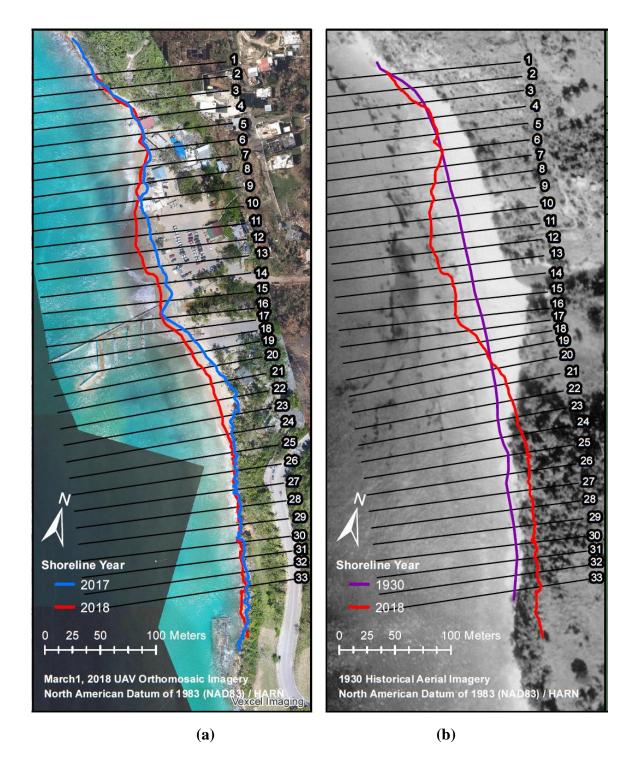
Figure 5-25. Shoreline changes at Crash Boat Beach, Aguadilla for period (a) 2017-18 and (b) net shoreline change from 1930 to 2018

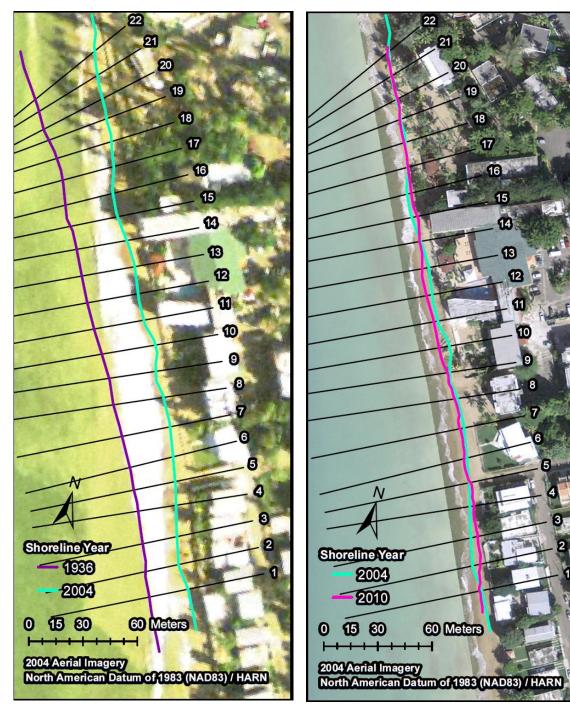
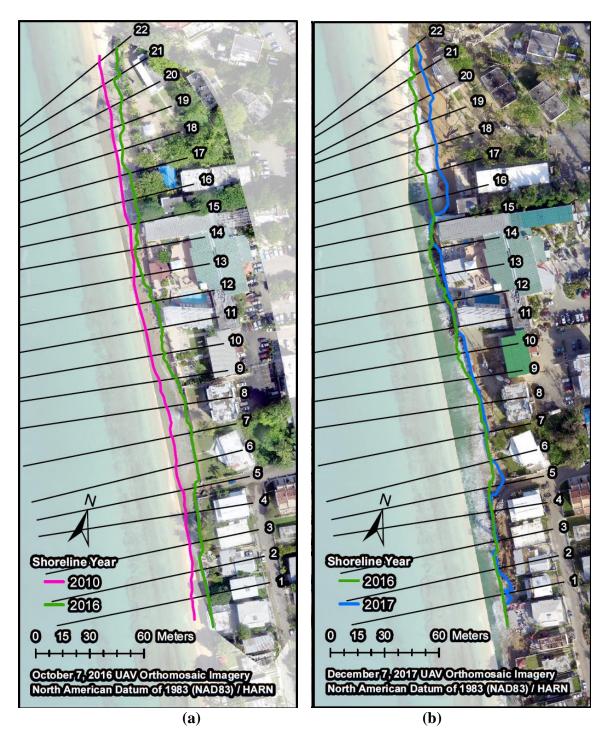
Figure 5-26. Shoreline changes at Cofresí Beach, Rincón for periods (a) 1936-2004 and (b) 2004-10

Figure 5-27. Shoreline changes at Cofresí Beach, Rincón for periods (a) 2010-16 and (b) 2016-17

The analysis of the historical shoreline positioning maps for Cofresí Beach at Rincón, for the period from 1930 to 2004 (Figure 5-26a), presented a significant retrieve. A possible cause may have been the development of homes and tourist places along the coast. Meanwhile, from 2004 to 2010 the coastline presented a recovery (Figure 5-26b). Possible causes could have been the sand nourishment for beach restoration or other methods that compensate for the regression. During the period 2010 to 2016 (Figure 5-27a), the coastline had a significant setback; this was caused by Hurricane Matthew (Category 4) event on October 4, 2016 during its near passage to the west coast of Puerto Rico. Although Hurricane Matthew was not a direct threat to Puerto Rico since he was 500 nautical miles away, the direction of the swell was extremely rare to rhis stretch of coast which severely impacted western coast of Puerto Rico. On October 4, 2016 CARICOOS Rincón buoy measured waves with a maximum significant wave height of 1.67 meters, 11 seconds peak period and peak wave direction of 279°, which highly affected the shoreline position. Likewise, during the period 2016 to 2017 (Figure 5-27b), the coastline presented a retrieve, causing the total loss of the beach. This behavior was caused by the passage of the Hurricane Maria through Puerto Rico. From 2017 to 2018 (Figure 5-28a), the coastline remained almost in the same place, continuing with the loss of the beach. Comparing the period of 1936 with 2018 (Figure 5-28b), the beach has gone backwards, showing severe erosion events.

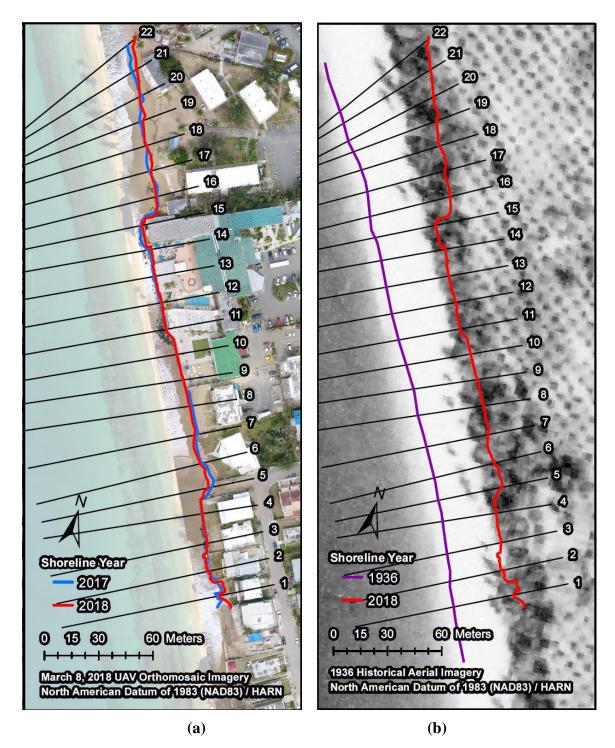
Figure 5-28. Shoreline changes at Cofresí Beach, Rincón for period (a) 2017-18 and (b) net shoreline change from 1936 to 2018

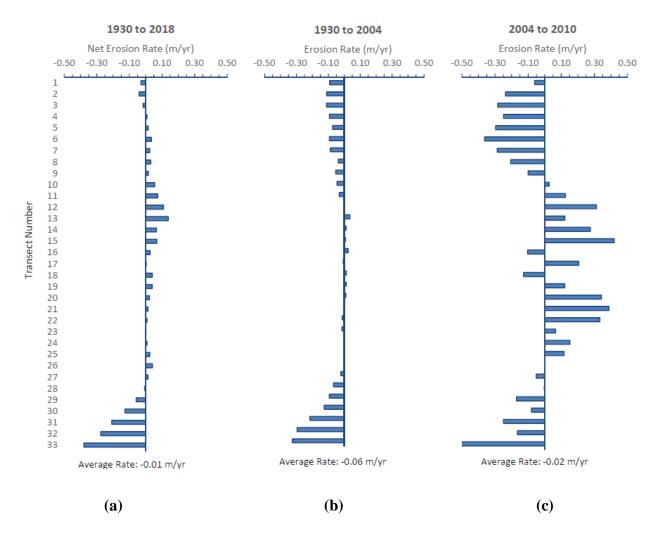
Figure 5-30. Average EPR results for periods (a) 1930-2018, (b) 1930-2004, and (c) 2004-10 at Jobos Beach, Isabela

Comparing these results, there is a pattern of shoreline behavior that may be an indicator of future trends assuming continuity in the environment. Additionally, as previously mentioned, the higher erosion event from 2016 to 2017 was due the Hurricane María event in 2017.

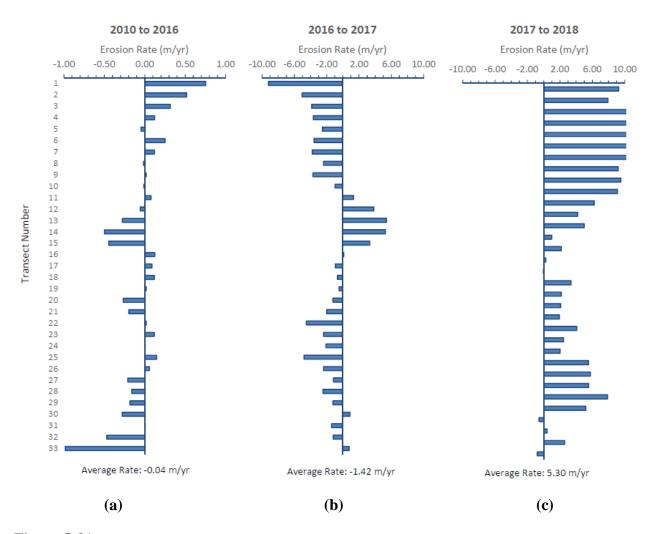
**Figure 5-31.** Average EPR results for periods (a) 2010-16, (b) 2016-17, and (c) 2017-18 at Jobos Beach, Isabela

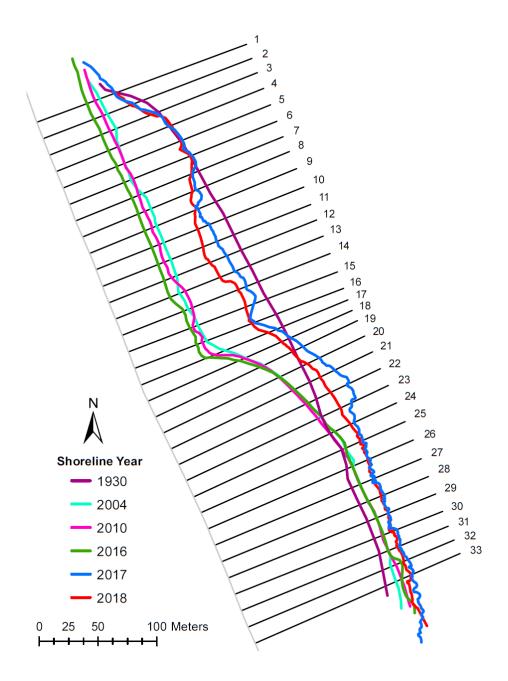
Figure 5-32. Transect numbers for the shoreline changes analysis at Crash Boat Beach, Aguadilla

Figure 5-32 shows the rate of change for Crash Boat Beach at Aguadilla obtained from the statistical calculations provided by DSAS, using the 33 transects. The distance from baseline values needed for the EPR calculations are indicated in Table 5-11. The EPR results determined by DSAS for each transect and for the periods 1930-2018, 1930-2004, 2004-10, 2010-16, 2016-17, and 2017-18, are indicated in Table 5-12. Additionally, the EPR results and the average EPR for each period are shown in Figures 5-33 and 5-34. Based on the average EPR results, Crash Boat Beach showed a net erosion rate of 0.00 m/yr for the period 1930 to 2018 (Figure 5-33a). Analyzing the other periods, Crash Boat accreted 0.38 m/yr from 1930 to 2004 (Figure 5-33b), 0.28 m/yr from 2004 to 2010 (Figure 5-33c), 0.54 m/yr from 2010 to 2016 (Figure 5-34a), eroded -38.11 m/yr from 2016 to 2017 (Figure 5-34b), and accreted 5.51 m/yr from 2017 to 2018 (Figure 5-34c). As previously mentioned, the accretion for the period 1930 to 2004 was induced by the construction of a pier/dock for the Ramey Air Force Base. Although the erosion rate for the period 2016 to 2017 is significant, it does not affect the net result due to the small year period, compared to the 1930 to 2004 period (1 vs. 74 yrs). This erosion event was due the impact of Hurricane María. The accretion for the period 2017 to 2018 was due to the onshore sediment transport.

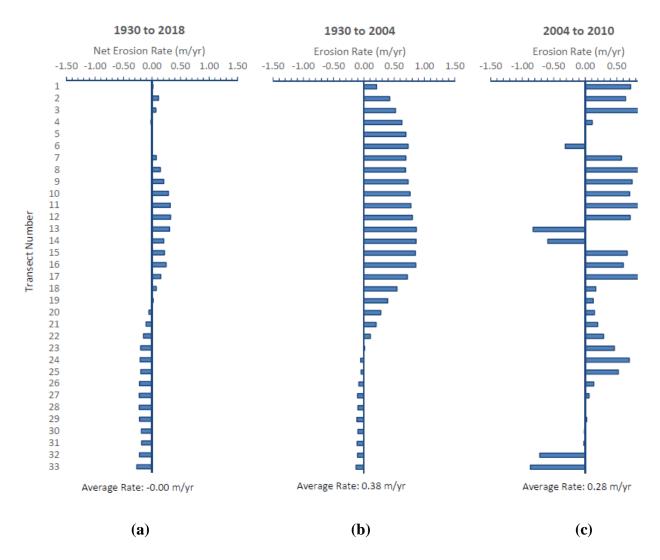
Figure 5-33. Average EPR results for periods (a) 1930-2018, (b) 1930-2004, and (c) 2004-10 at Crash Boat Beach, Aguadilla

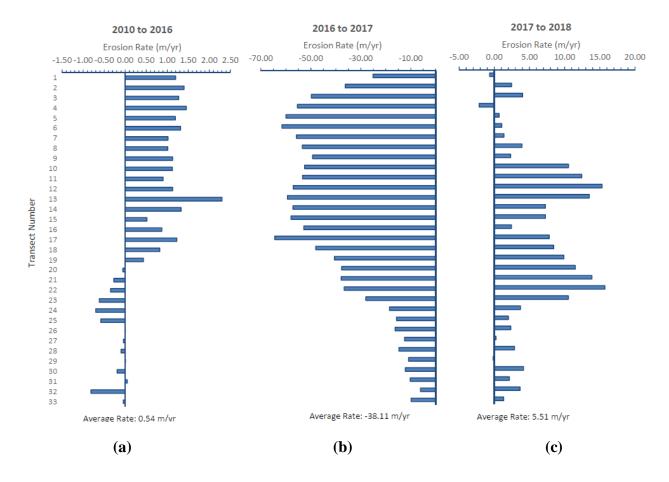
Figure 5-34. Average EPR results for periods (a) 2010-16, (b) 2016-17, and (c) 2017-18 at Crash Boat Beach, Aguadilla

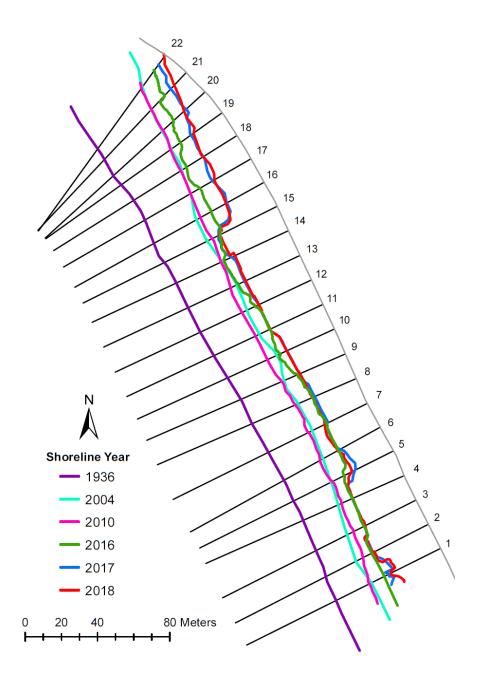
Figure 5-35. Transect numbers for the shoreline changes analysis at Cofresí Beach, Rincón

Figure 5-35 shows the rate of change for Cofresí Beach at Rincón obtained from the statistical calculations provided by DSAS, using the 22 transects. The distance from baseline values are indicated in Table 5-13. The EPR results determined by DSAS for each transect and for the periods 1936-2018, 1936-2004, 2004-10, 2010-16, 2016-17, and 2017-18, are indicated in Table 5-14. Additionally, the EPR results and the average EPR for each period are shown in Figures 5-36 and 5-37. Based on the average EPR results, Cofresí Beach showed a net erosion rate of -0.48 m/yr for the period 1936 to 2018 (Figure 5-36a). Analyzing the other periods, Cofresí Beach eroded -0.41 m/yr from 1936 to 2004 (Figure 5-36b), accreted 0.08 m/yr from 2004 to 2010 (Figure 5-36c), and eroded -1.27 m/yr from 2010 to 2016 (Figure 5-37a), -3.82 m/yr from 2016 to 2017 (Figure 5-37b), and -0.34 m/yr from 2017 to 2018 (Figure 5-37c). The short-term period of 2016 to 2017 is nearly eight times the long-term average. This could be due storm influences, sea-level change, and other factors. According to previous studies, this area had an average longterm erosion rate of -0.4 m/yr for the period 1936 to 2006, and -0.7 m/yr for the period 1994 to 2006 (Thieler et al. 2007). Comparing these results, there is a very consistent trend over time that continues to happen, showing severe erosion events. If no action is taken and the trend continues, infrastructures along the coastline will be permanently damaged.

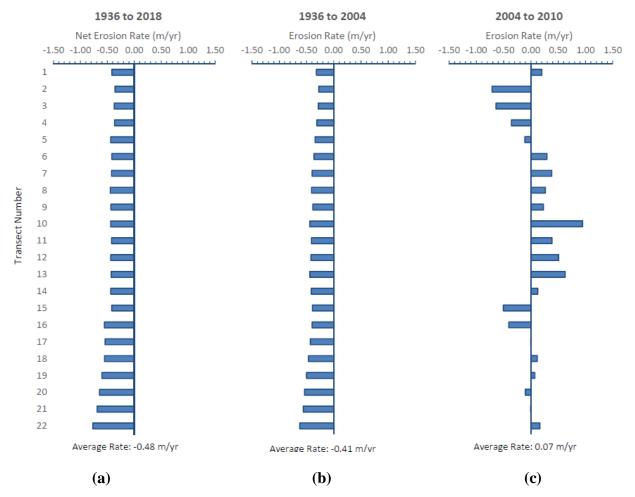
Figure 5-36. Average EPR results for periods (a) 1936-2018, (b) 1936-2004, and (c) 2004-10 at Cofresí Beach, Rincón

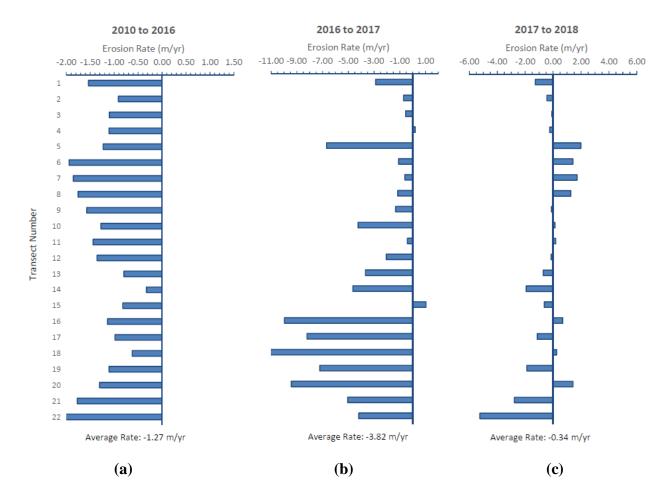
Figure 5-37. Average EPR results for periods (a) 2010-16, (b) 2016-17, and (c) 2017-18 at Cofresí Beach, Rincón

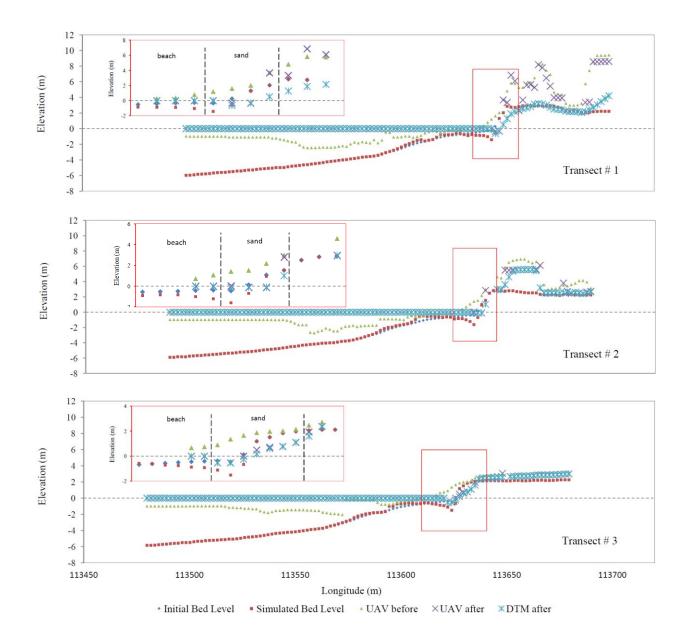
Figure 5-38. Profiles of the bed level change for transects 1 to 3 before and after Hurricane Matthew

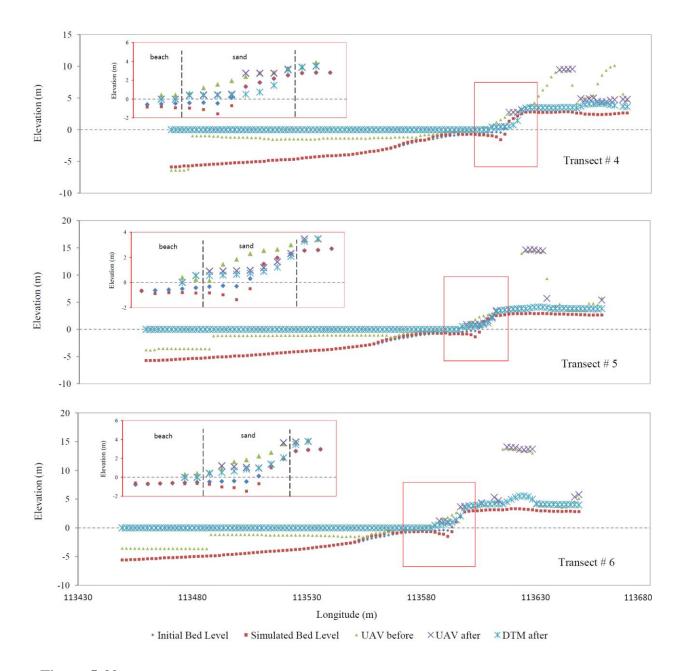
Figure 5-39. Profiles of the bed level change for transects 4 to 6 before and after Hurricane Matthew

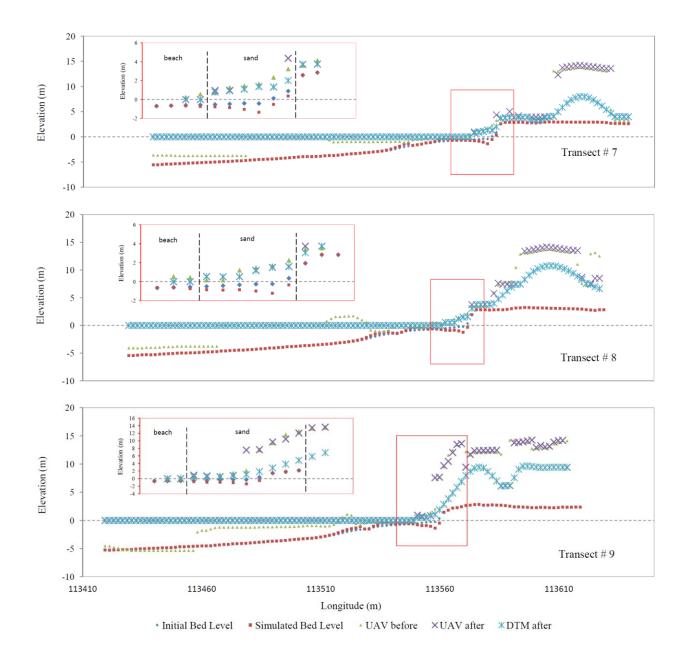
Figure 5-40. Profiles of the bed level change for transects 7 to 9 before and after Hurricane Matthew

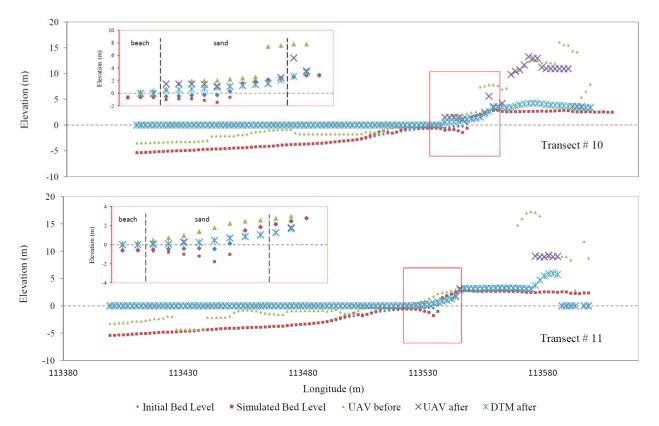
Figure 5-41. Profiles of the bed level change for transects 10 to 11 before and after Hurricane Matthew

leading to overestimate the actual elevation. Similarly, for transects 10 and 11 (Figure 5-41), both profiles were quite similar in behavior; except for transect 10 in were the elevation from the DSM pre-storm was also overestimate. This could also be due to vegetation located along the transect that could cause wrong assignment to the pixel value.

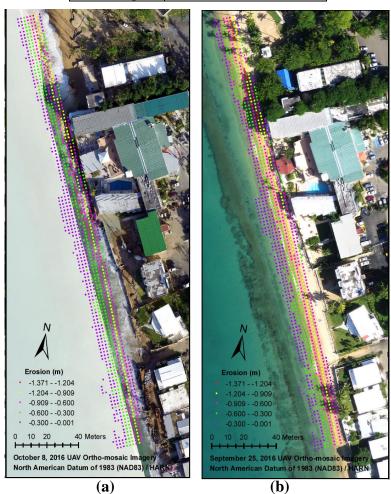
Figure 5-42. Erosion values from the simulation results along the coastline using UAV ortho-mosaic images (a) before and (b) after Hurricane Matthew

The averaged erosion results in the vertical direction of the numerical simulation were determined and summarized in Table 5-15. These values were obtained for each transects from the subtraction of the simulated erosion results and the initial bed level values obtained from the USACE DTM. All the transect values were then averaged obtaining the overall erosion value of - 0.693 meters in the vertical direction. These results were used to generate the maps shown in Figure 5-42.

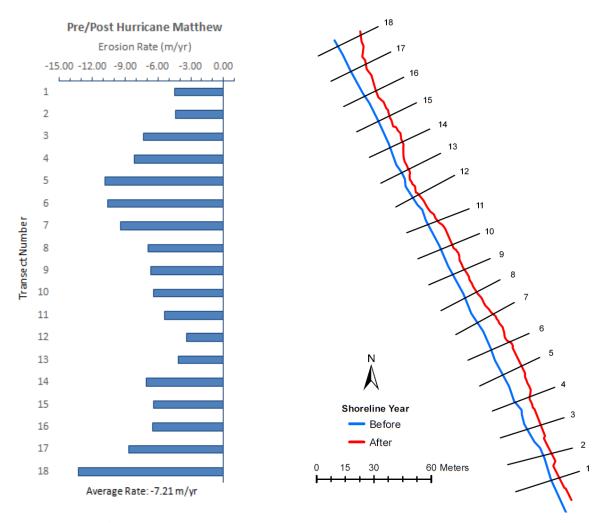
Figure 5-43. Shoreline changes results before and after Hurricane Matthew

The rate of change for Cofresí Beach at Rincón pre- and post-storm obtained from the statistical calculations provided by DSAS, using the UAV images and the 18 transects shown in Figure 5-43. The distance from baseline values needed for the EPR calculations, and the EPR results are shown in Table 5-19. The EPR values for each transect were then averaged obtaining the overall erosion value of -7.21 meters in the longitudinal direction.

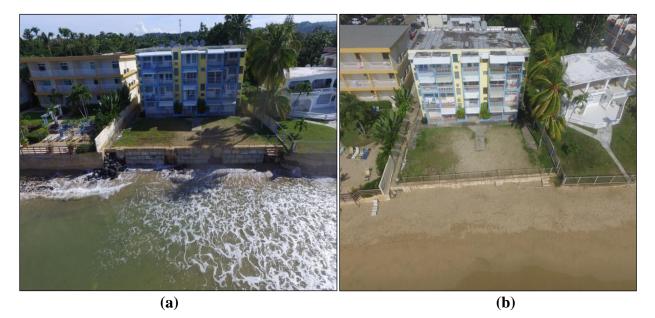
Figure 5-44. Temporary erosion event (a) during Hurricane Matthew on October 8, 2016 and (b) after Hurricane Matthew on October 14, 2016

However, for the statistical analysis in the longitudinal direction, transects 5, 6, 7, 12, and 18 were not selected since at the moment of capturing the UAV image, the swell was at its peak and it was difficult to accurately determine the wet/dry line. It should be noted that a temporary erosion event was detected. Days after the hurricane the beach returned to its initial state (Figure 5-44).

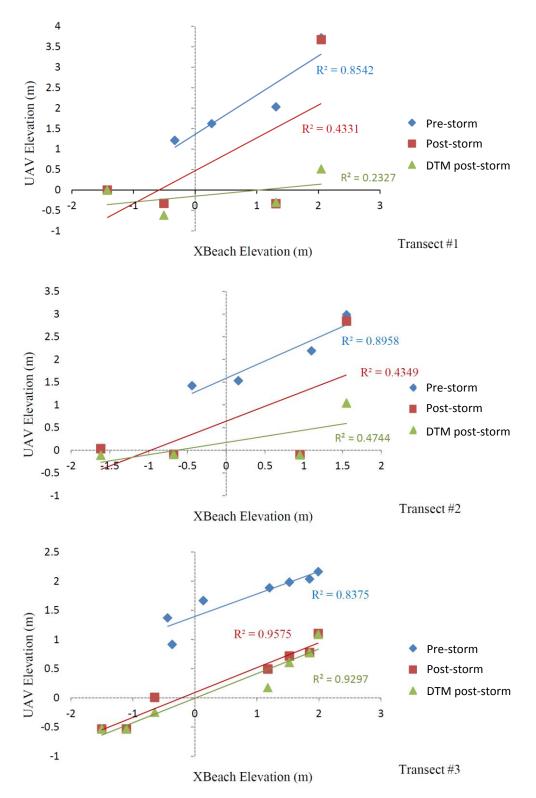
Figure 5-45. Correlation analysis for transects 1, 2, and 3

The following charts (Figures 5-45 to 5-48) were generated to evaluate how the profiles behaved in their shape. Charts were created using the beach portion of the XBeach and UAV DSMs data pre- and post-storm. The pre-storm values corresponded to the comparison of the XBeach and UAV DSM data before Hurricane Matthew; the after values corresponded to the comparison of the XBeach and UAV DSM data after Hurricane Matthew. The DTM post-storm values corresponded to the comparison of the XBeach and UAV DTM data after Hurricane Matthew. It includes the DTM elevations after the hurricane in order to evaluate if there is any difference using a DSM or DTM to detect morphological changes.

Analyzing the correlation results before Hurricane Matthew, almost all of them showed high  $R^2$  values. These results may have been influenced since the DSM had the bathymetry data combined with the topography. The post-storm results, compared with the pre-storm results, were lower almost in all transects. Similarly, this could have been caused since our DSM did not have bathymetry data. The DTM  $R^2$  results were quite similar with the DSM, except for a few transects. Overall, the average  $R^2$  values from pre- and post storm were acceptable, and the difference between the used of DSM and DTM for the detection of morphological changes was almost negligible. The  $R^2$  post-storm results could improve by implementing a hybrid model that includes bathymetry data and optimizing the DSM and DTM with more ground control points.

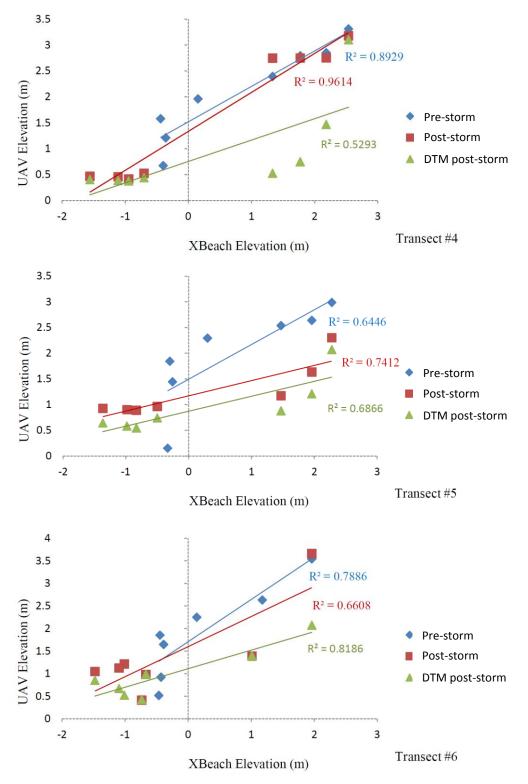
Figure 5-46. Correlation analysis for transects 4, 5, and 6

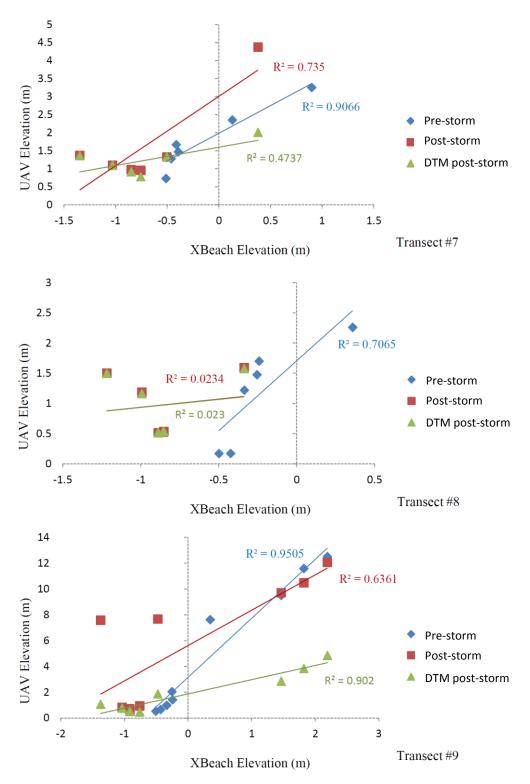
Figure 5-47. Correlation analysis for transects 7, 8, and 9

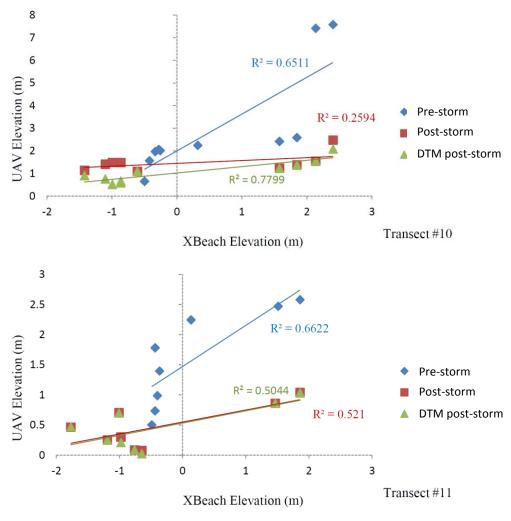
Figure 5-48. Correlation analysis for transects 10 and 11
